Crash of the Polish Governmental Plane PLF 101 in Smolensk¹

April 10, 2010

Status Report Dated November 11, 2011²

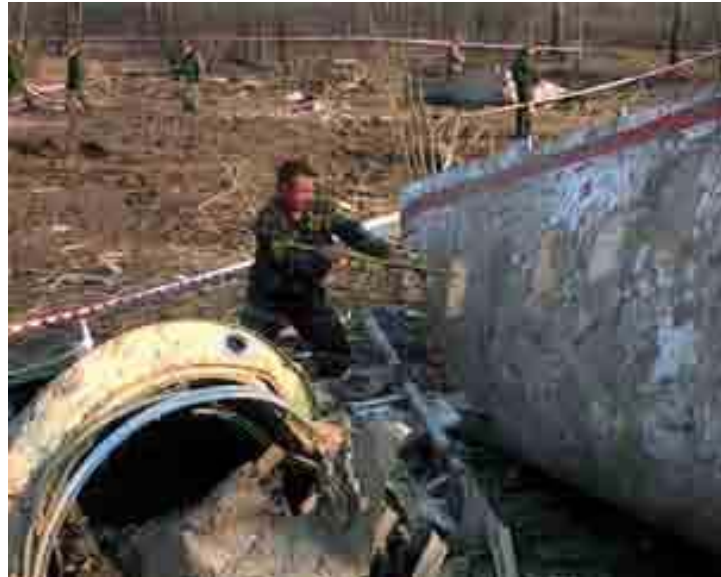
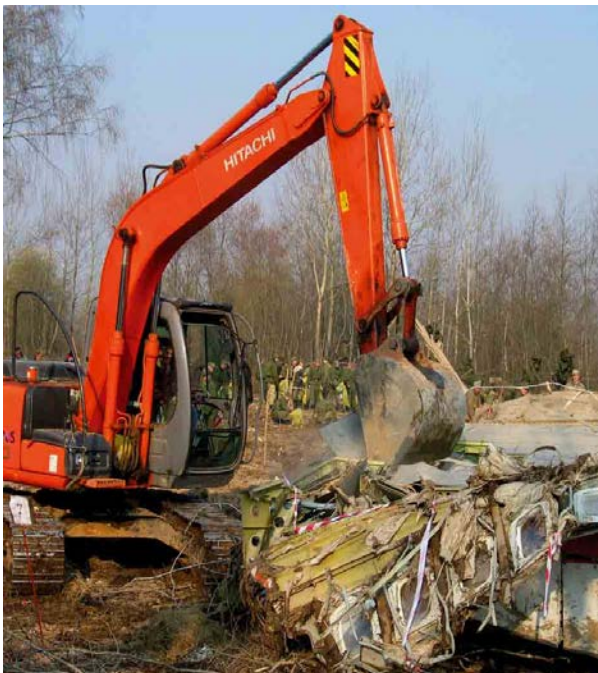
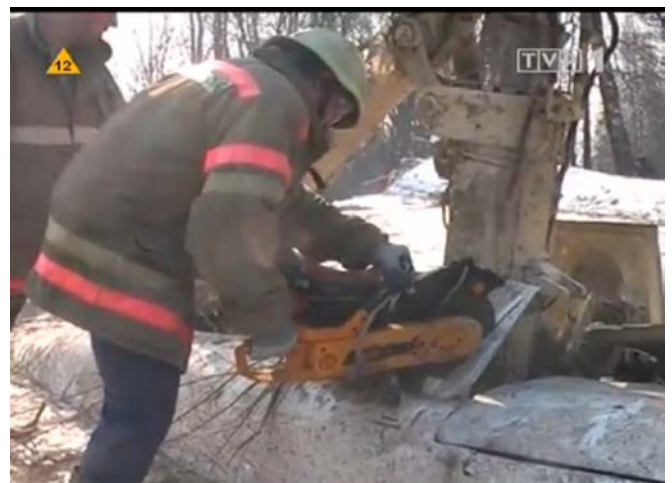
Photos Taken at the Scene of the Smolensk Crash on April 11, 2010⁷⁴

Appendix 1: Destruction of Evidence
