HYPOTHETICAL COLLISION OF TU-154M WITH BIRCH TREE VERSUS FULL-SCALE CRASH DYNAMIC TESTS OF DC-7 AND LC-1649

Professor **Jacek F. Gieras**, PhD, DSc, Fellow IEEE
University of Technology and Life Sciences, Bydgoszcz, Poland

Smolensk Conference, Warsaw, 22.10.2012

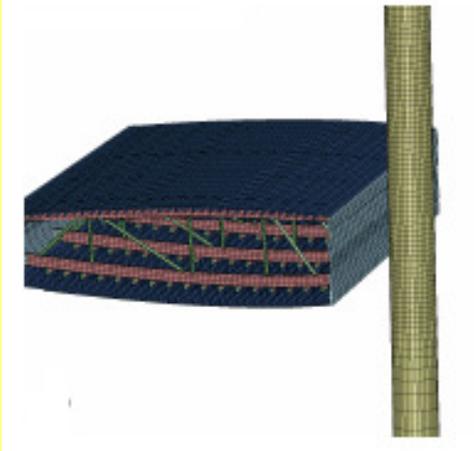
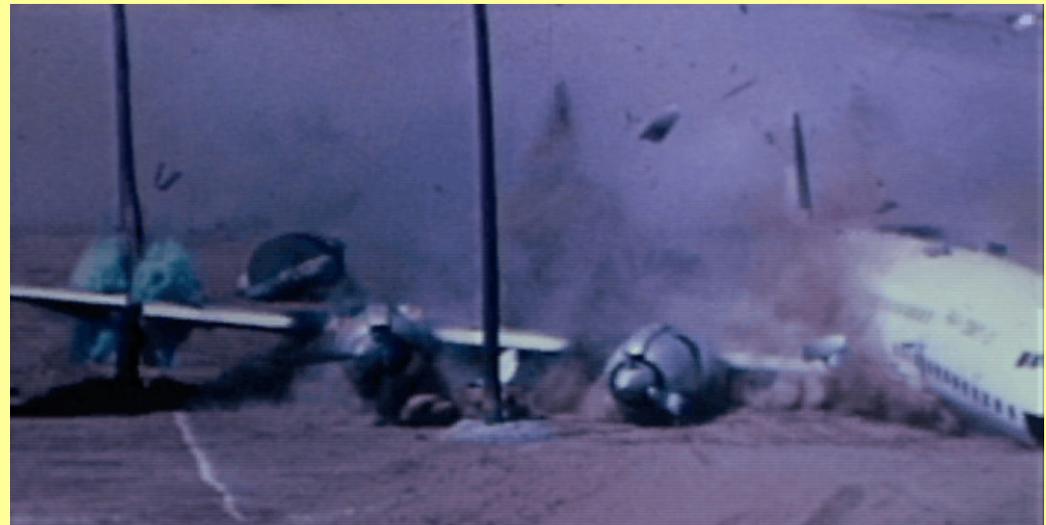
Inboard pole impact

The LC-1649 was made from higher-strength, low-elongation aluminum similar to modern aircraft.

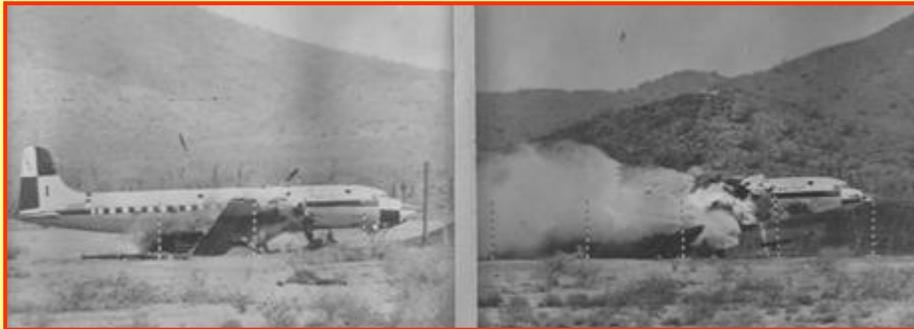
Photo on left shows the DC-7 wheels clipped off and one wing struck by a telephone pole. Photo on the right shows the DC-7 begins to explode into flames apparently unplanned.

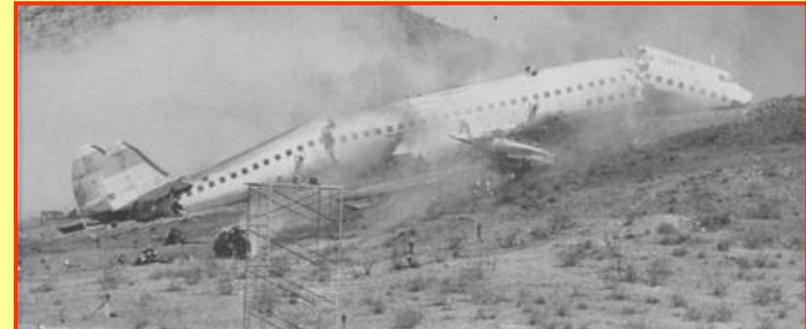
LC-1649 destroyed in the test at Deer Valley. Photo taken by C. Baird.

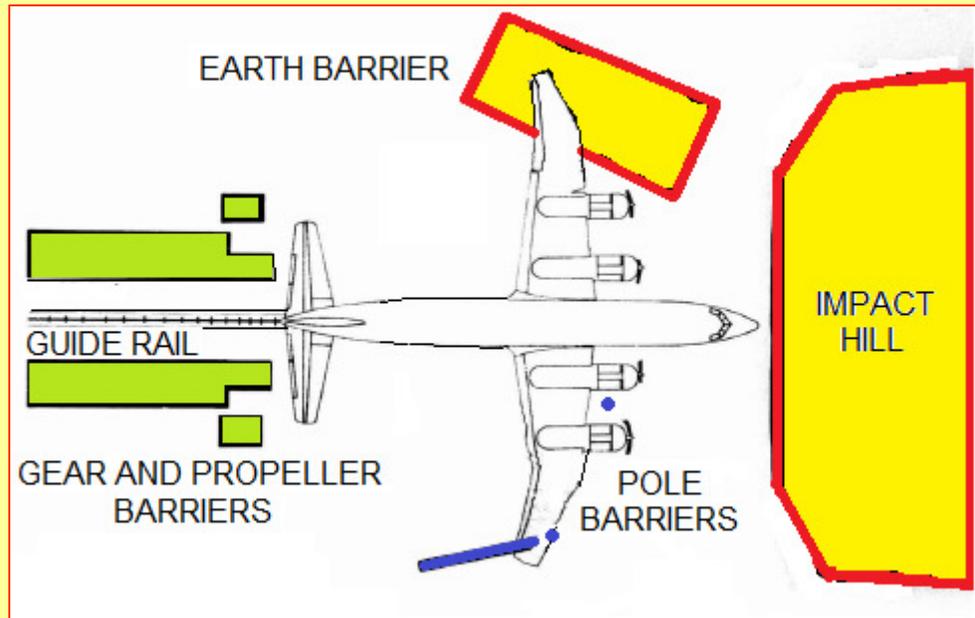
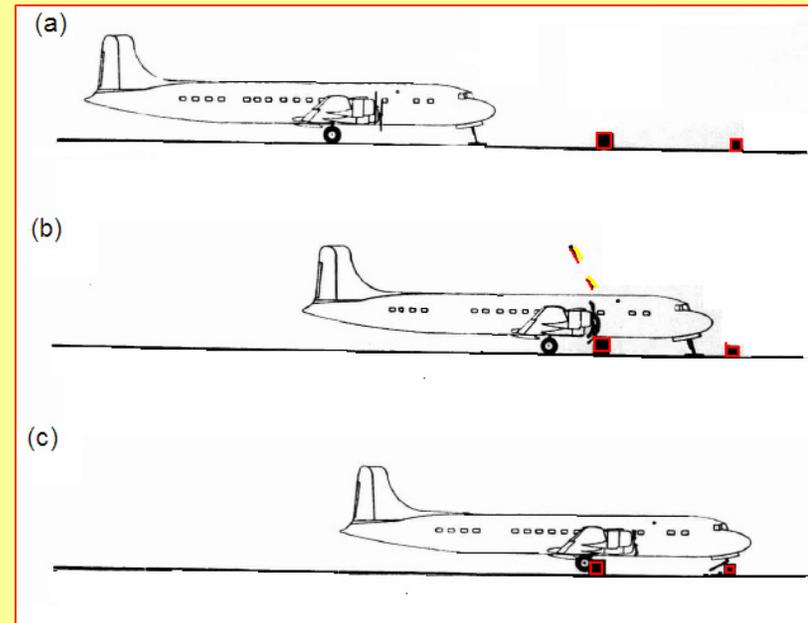
Gear and propeller impact sequence

1. The first barrier was the landing gear barrier.
2. All four propellers were broken as a result of hitting the propeller barriers. All four engine mounts failed.
3. The gear barrier torn out the right main landing gear
4. The outer pole cut off the right wing approximately 3.66 m (12 feet) from the tip.
5. The aircraft hit the second inner pole approximately 0.15 s after the first pole impact. The inner pole struck the right wing between engines No 3 and No 4. The wing leading edge structure back to the forward spar was crushed. Then, the inner pole broke.

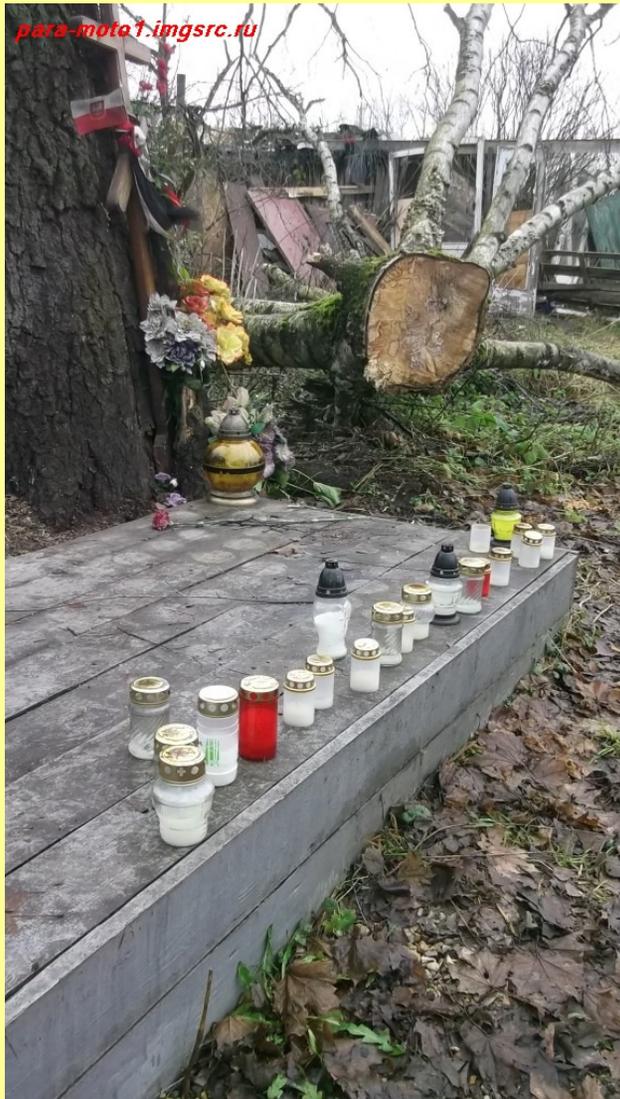
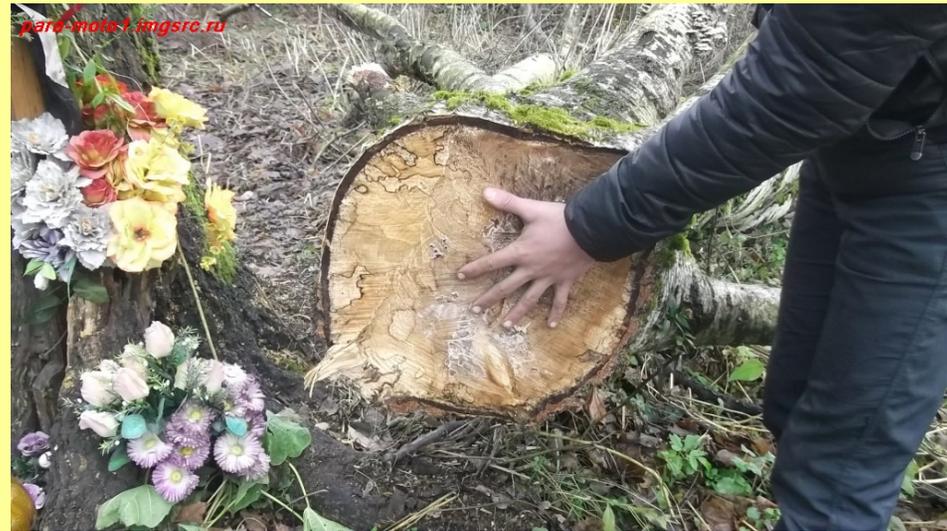
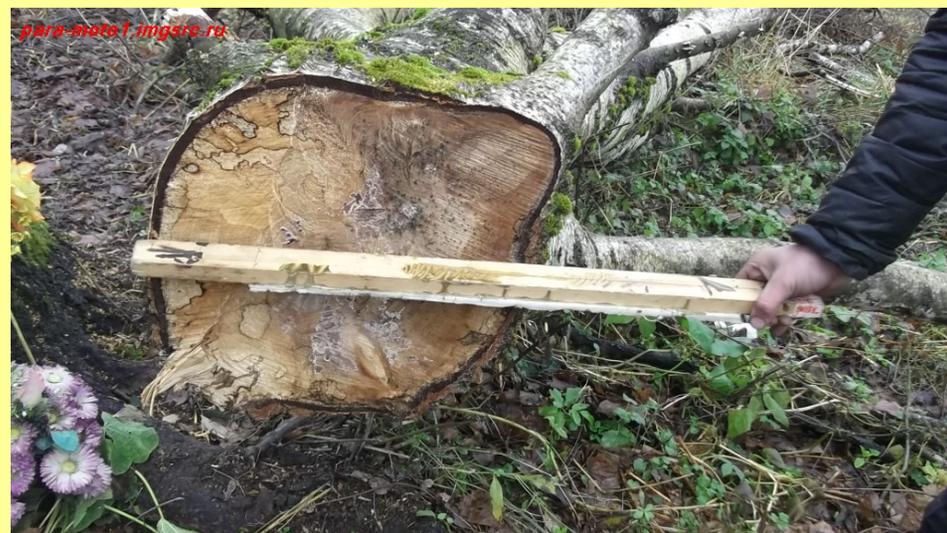
Recent photographs. The most important portion has been cut off.

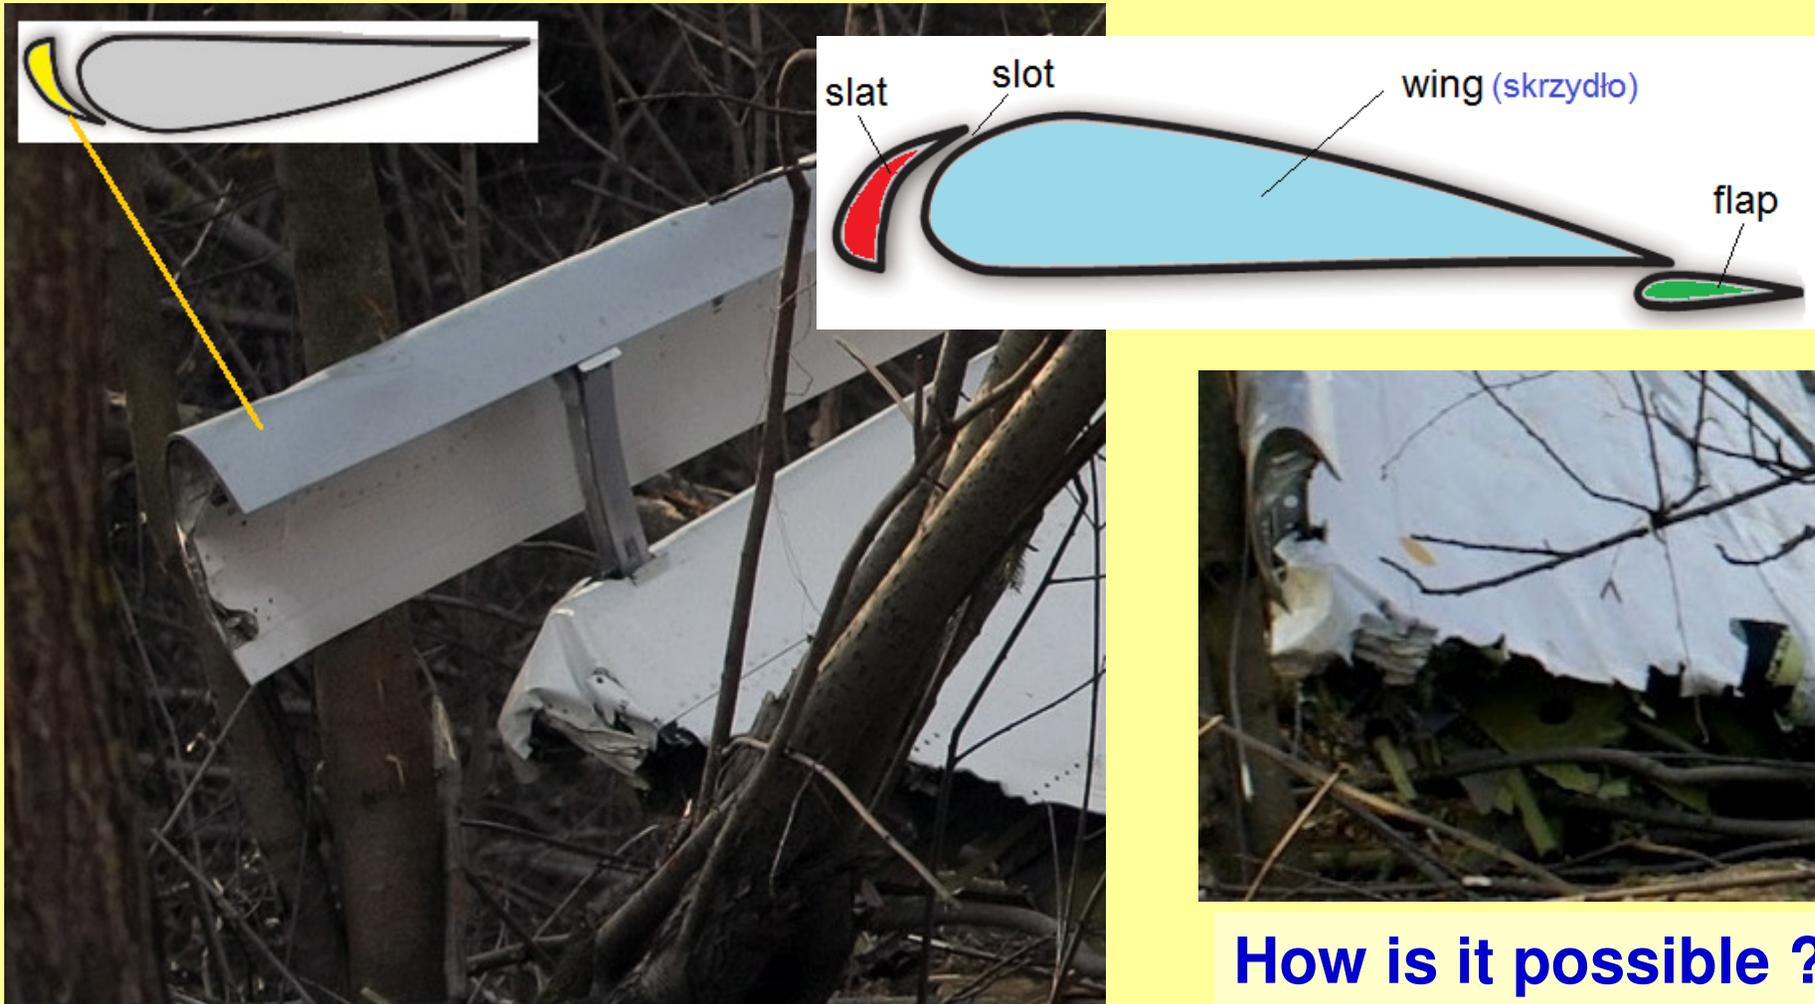
Tip of left wing of Tu-154M No 101

The wing has been cut off while the front edge **slat is intact**

- (h) Research performed at the University of Akron and University of Maryland, photographs of the birch taken immediately after crash, lack of damage to the slat and lack of detailed investigation of the birch tree and wing immediately after crash testify that there was rather no collision of the **Tu-154M** Nr 101 with a birch tree.
