# ANALYSIS OF COMPONENTS OF ELECTRIC SYSTEM OF THE TU-154M PLF 101 AFTER CRASH

Jacek F. Gieras<sup>1)</sup>, Marek Dąbrowski<sup>2)</sup>

An attempt to localize and analyse the distribution of components of electric system on the crash site of the Tu-154M PLF101 aircraft on April 10, 2010 has been presented. All available sources of information as photographs, movies, articles, reports and blogs have been used. Only a few components of the electric system have been recorded in available documents. Location of components and parts of the electric systems can help to trace the sequence of disintegration of the aircraft.

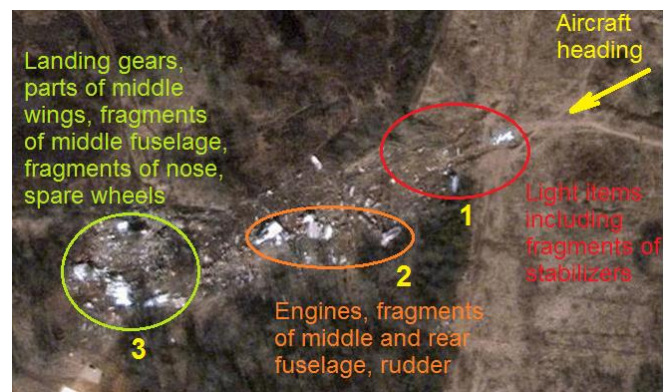
Many publications devoted to the Tu-154M PLF 101 crash in Smolensk on April 10, 2010 have been elaborated so far by independent researchers, engineers, lawyers, journalists and sociologists. Although the wreckage and original “black boxes” are not available for independent investigations, the common conclusion from these publications is that the *Tu-154M PLF 101 aircraft did not crashed as a result of collision with ground, but the aircraft disintegrated in the air*. This conclusion is supported by:

- distribution of debris (Fig. 1);
- large number (tens of thousand) of small parts on the crash site;
- fragments of the aircraft skin on trees;
- lack of crater;
- lack of fuel (at least no records) and fuel fire on the ground.

**Fig. 1.** The Tu-154M PLF 101 wreckage trail plot grouped by location of parts of the aircraft: (1) light items including fragments of stabilizers; (2) engines, fragments of middle and rear fuselage, rudder; (3) landing gears, parts of middle wings, fragments of middle fuselage, fragments of nose, spare wheels.

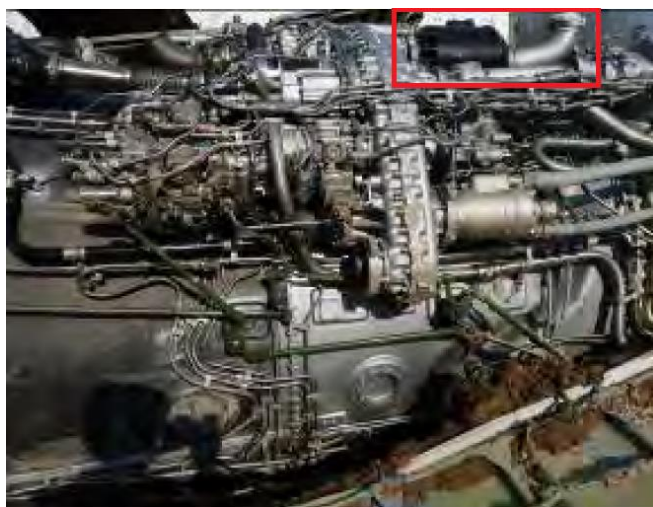
Main synchronous generators are hidden under engine cowl (cover) and if the engines are not shattered, the generators are invisible. The only available photographs are in Annexure No 4.20.22 „Note on the inspection at crash site of the Tu-154M No 101 on April 11-13, 2010” to the CINAA (KBWLLP) Report [6], which show the main generator on the left engine No 1 (Fig. 4). The generator and associated gauges look undamaged and are firmly fixed to the engine body. Other photographs of GT40PCh6 generators taken after crash of the Tu154M PLF101 are not available.

Fig. 4. Generator GT40PCh6 on the engine No 1 (left). The engine cover (cowl) has been removed. Photo taken between 11 and 13 April 2010 on the crash site. Source: Annexure No 4.10.22 to KBWLLP Report [6].

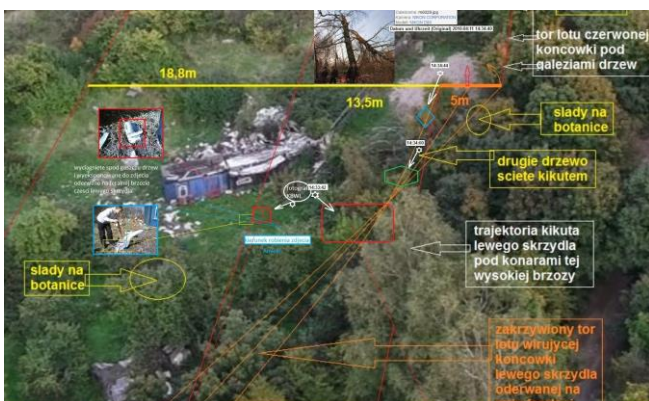
**Fig. 8. Location of screw actuator of flaps and electromagnetic brake TМ-4 on N. Bodin's lot before Gubenko Street. Source: elaboration by blogger Wielki55.**

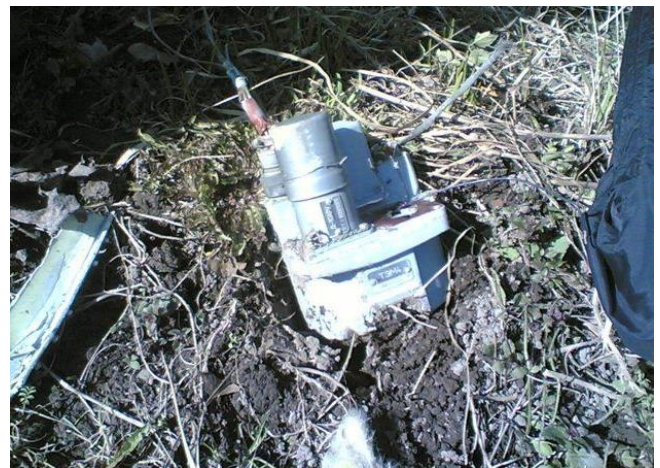
Both photographs in Fig. 9 and Fig. 10 have been downloaded on April 10, 2010 at 18:44 by a Russian blogger MAK at <http://www.forum.smolensk.ws>. The photograph of the same parts shown in Fig. 11 has been taken later. The authors' request for the date and time of this photograph being e-mailed to the Team for Explanation of Causes of Smolensk Crash [7], personally to M. Lasek, the chairman, has remained unanswered.

**Fig. 9. Electromagnetic brake TEM-4. Photograph taken probably on April 10 2010 before 18:44. Source: <http://www.forum.smolensk.ws/viewtopic.php?p=6889622#p6889622> Author: MAK5.**

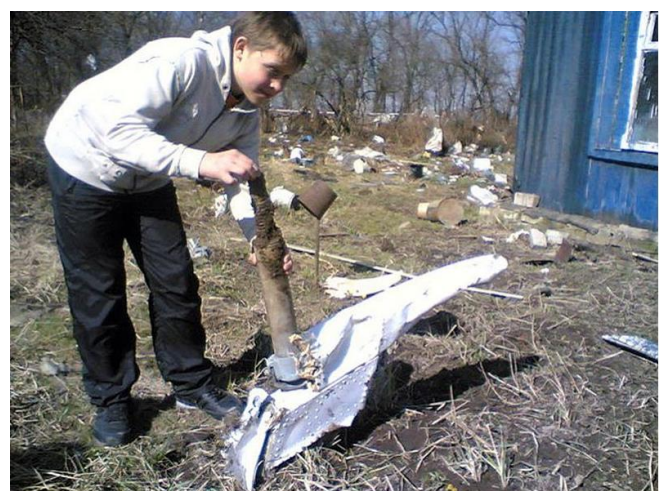
The photo of the screw actuator of flaps (Fig. 10) shows that this part dropped from the aircraft before the birch tree at N. Bodin's lot. The Interstate Aviation Committee (MAK) report [8] indicates the location of the actuator behind the birch tree (Fig. 7). Without doubt, the illustrative material in figures Fig. 8 to Fig. 11 is a proof that the screw actuator of flap control and electromagnetic brake TМ-4 have been intentionally moved at the crash site to make the official version of the crash [8, 9, 6] more authentic. In the official version of the crash [8, 9, 6], the "armored" birch tree is the main cause of the crash.

**Fig. 10. Screw actuator of flaps found near N. Bodin's shed. Source: S. Amielin [10].**

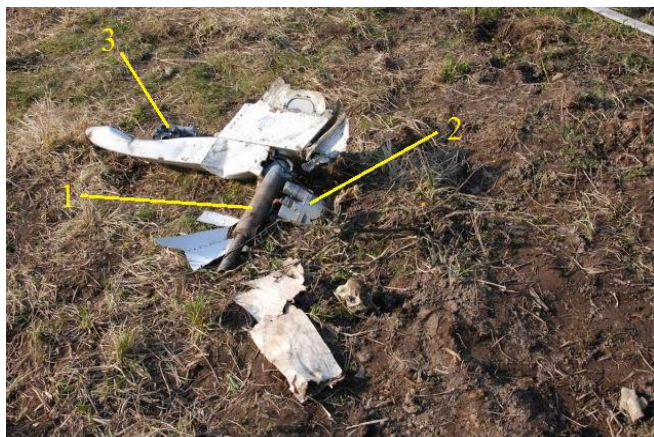
Fig. 11. Screw actuator for left wing flaps (1), electromagnetic brake ТЭМ-4 (2) and reducer (3). Photo taken by IAC (MAK) [8] Source: [www.fakty-smolensk.gov.pl](http://www.fakty-smolensk.gov.pl)

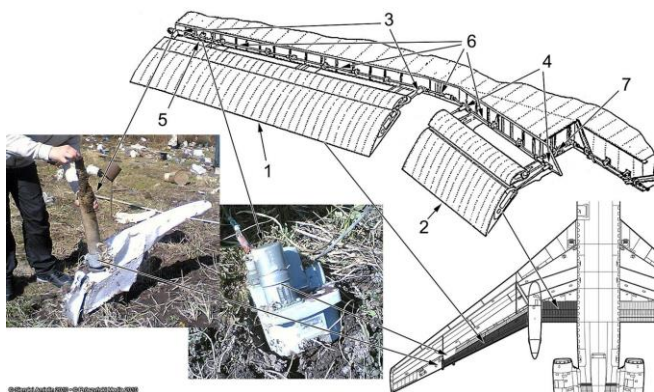
The principle of the flap control of the Tu-154M aircraft is shown in Fig. 12 Flap actuators are used to move the flaps transforming screw rotation into forward movement of flaps. The angle of deflection of flaps is from 0° to 45°. A hydro-electro-mechanical system has been designed for pulling-out and retraction of flaps. The mechanism SPZ-1A for moving the flaps consists of a transmission and screw actuators. The transmission of flaps transfers the torque from the steering gear to the screw actuators and provides synchronous sweep-up and pull-out of flaps on right and left wings. Transmission is located on the rear wall of the third spar including the detachable part of the wing. Transmission consists of shafts, supports, airtight tips (terminals) and reducers. Shafts are made of mutually connected duralumin transmission tubes, reducers, slotted tips of screw actuators and cardan shafts. Cardan shafts are used to connect the transmission shafts if their axles intersect at an angle of up to 8°. Cardans eliminate bending and jamming of transmissions upon deformation of the wing and serve to compensate for this mutual displacement of its mechanisms.

Fig. 12. Parts of flap control system found on crash site and principle of flap control of the Tu-154M aircraft. 1 – outer flap, 2 - inner flap, 3 - screw actuator of outer flap control, 4 - screw actuator of inner flap control, 5 - electromagnetic brake TEM-4 of mechanism of flaps, 6 - transmission shaft, 7 - hydraulic motor. Source: S. Amielin [110].

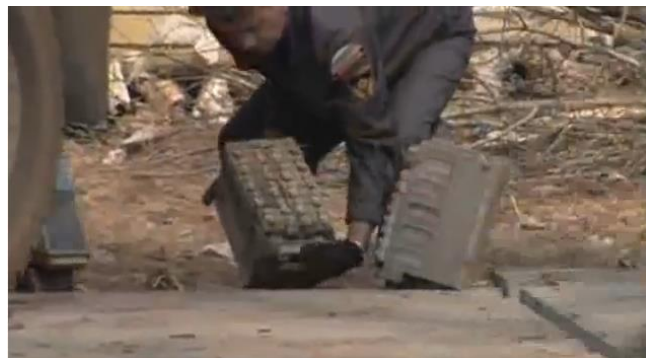
The Tu-154M aircraft is equipped with four 20HKБН-25-Y3 batteries and two spare batteries. Three out of six of the 20HKБН-25-Y3 batteries of the Tu-154M PFL 101 have been found undamaged at the crash site (Fig. 14).

Fig. 14. Undamaged batteries at the crash site. Source: SuperVizjer\_Smolensk\_4.wmv (<http://www.youtube.com/watch?v=dB08tmb12TQ>).

7. **Ni-CD batteries 20HKBH-25-Y3.** The available photo of 6 batteries shows that the three of them are visually in good condition, while the remaining 3 batteries are with damaged covers (broken and bent).

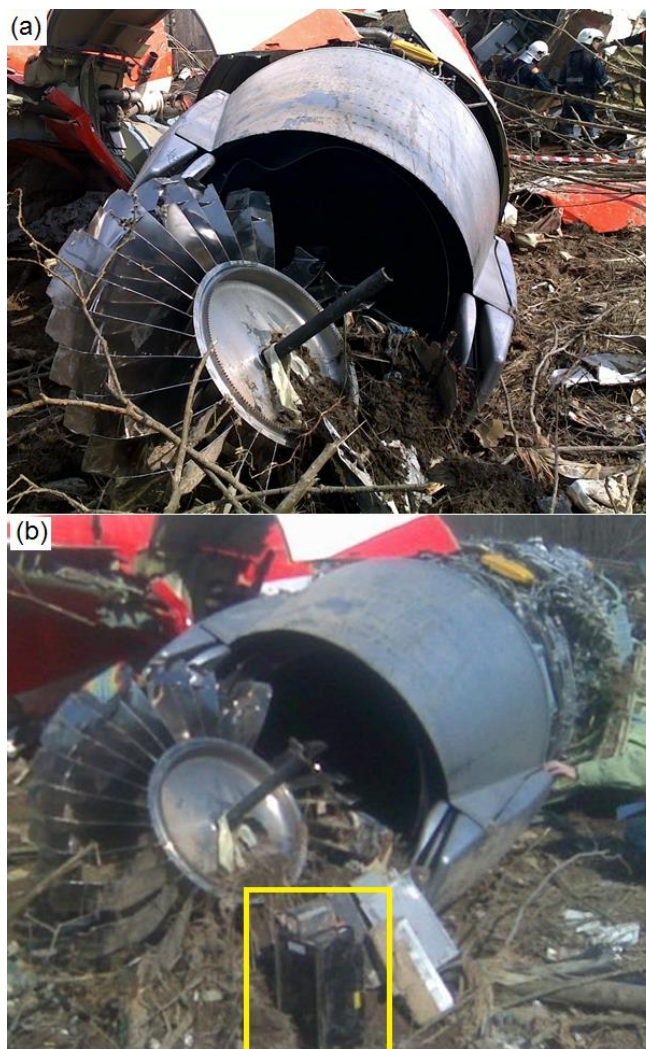
Fig. 15. Low pressure compressor (LPC) of the left engine No 1 at the crash site. (a) the blades were spinning before touching the ground because their tip portion is covered with soil (b) the object in rectangular frame beside the LPC is probably the battery 20HKБН-25-Y3. Source: Fig. 15a [www.fakty-smolensk.gov.pl](http://www.fakty-smolensk.gov.pl) , Fig. 15b unknown source.

It is impossible to locate on the basis of available illustrative material where the batteries have been dropped after the crash. Fig. 15 shows that the batteries have been moved at the crash site from place to place.

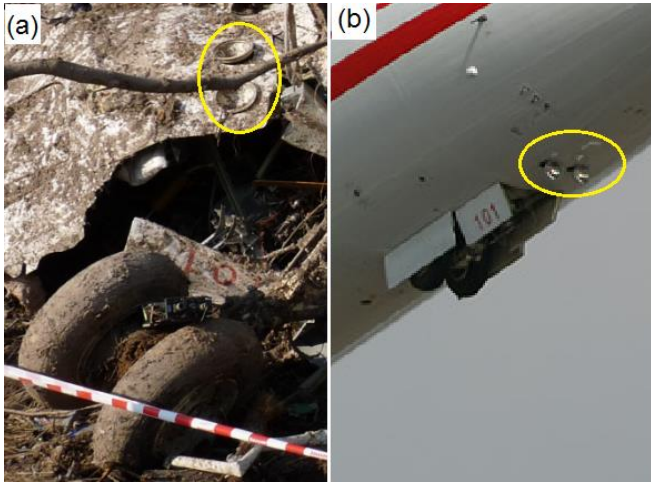
Fig. 16. Landing/taxi lights PRF-4 mounted on the fuselage of the Tu-154M PLF 101: (a) found on the crash site with broken glasses [8], (b) ejected lights at landing approach. Source: Fig. 16a Raport IAC (MAK) [8], Fig. 16b M. Franczyk, [www.galeria.aviateam.pl](http://www.galeria.aviateam.pl).

Each time, when the TU-154M approaches landing, the PRF-4 lights are always ejected, both at daytime and nighttime (Fig. 16b). It is enigmatic that after the crash the landing lights looked like in stowed position (Fig. 16a and Fig. 17).

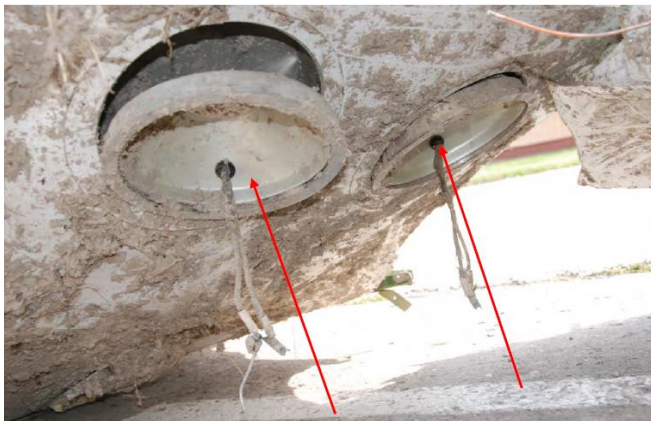
Fig. 17. Condition of landing/taxi lights PRF-4 mounted on the fuselage of the Tu-154M PLF101 after the crash. Photograph taken at the place of storage of the wreckage. Source: Annexure No 4 KBWL [6].

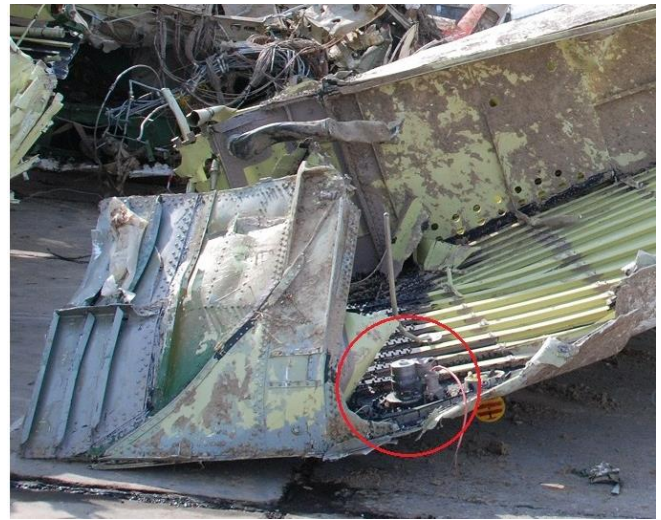
Fig. 18 and Fig. 19 show the fuel booster pump ЭЦН-325 of the wing fuel tank in the left centerwing at the place of storage of the wreckage.

Fig. 18. Fuel booster pump ЭЦН-325 of the wing fuel tank in the left centerwing. Photograph taken at the place of storage of the wreckage. Source: [www.fakty.molensk.gov.pl](http://www.fakty.molensk.gov.pl) [7].

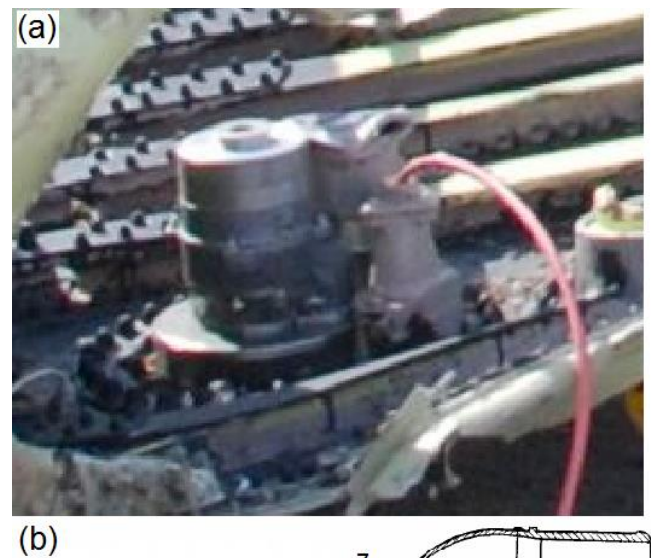
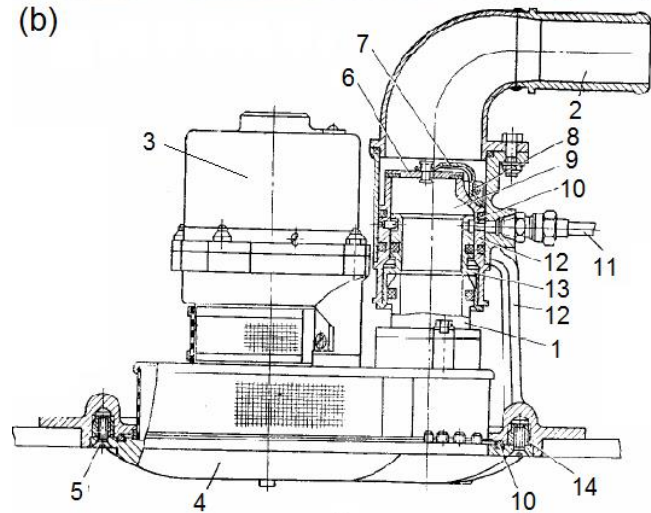
Fig. 19. Identification of the fuel booster pump ЭЦН-325: (a) magnified circled area of Fig. 18; (b) outline of the fuel booster pump ЭЦН-325 [3]: 1, 2 – tubes, 3 – induction motor driven pump, 4 – cover, 5 – screw, 6 – disk cover, 7 – lever, 8 – spring, 9 – non-return valve, 10 – rubber ring, 11 – pipeline, 12 – body, 13 – base, 14 – fittings.

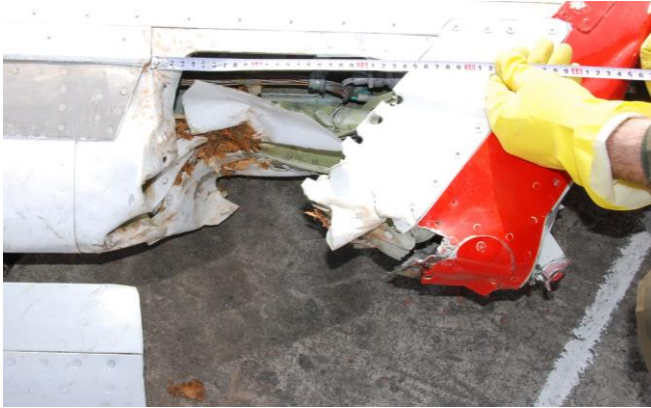
**Fig. 20.** A bundle of electric wires located before front spar of the detached portion of left wing. The front skin has been probably damaged when the severed part of wing hit the bushes at the crash site, while dropping. Note that slat covering the front skin has not been damaged Source: [www.faktysmolensk.gov.pl](http://www.faktysmolensk.gov.pl) [14 7].

A bundle of electric wires located before front spar of the detached portion of left wing is shown in Fig. 20. These wire can either be for energy delivery to the heating elements (de-icing of slats), to the fuel pumps, or electric

lighting. The front skin of the wing has been ripped off, while the slat covering the front skin has not been damaged.

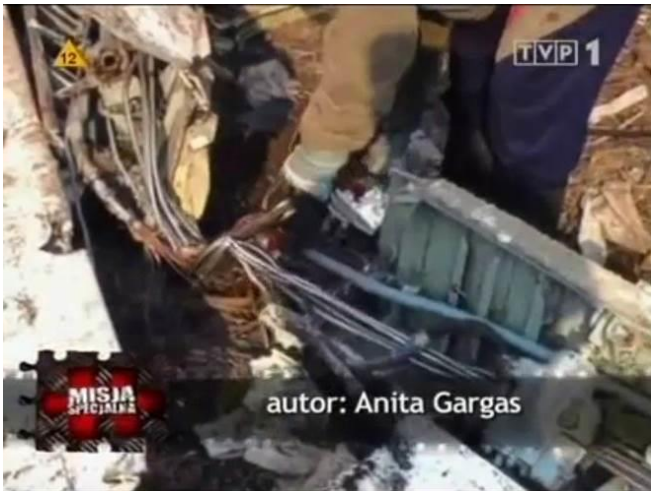
**Fig. 21.** Destruction of electric wiring and pneumatic hoses and tubing fixed the wing spar during rescue action at the crash site. Photo: A. Gargas, „Special Mission”, Polish TVP1 program.

Fig. 21 shows how the pneumatic hoses and tubing and electric wires have been destroyed by Russians at the crash site.

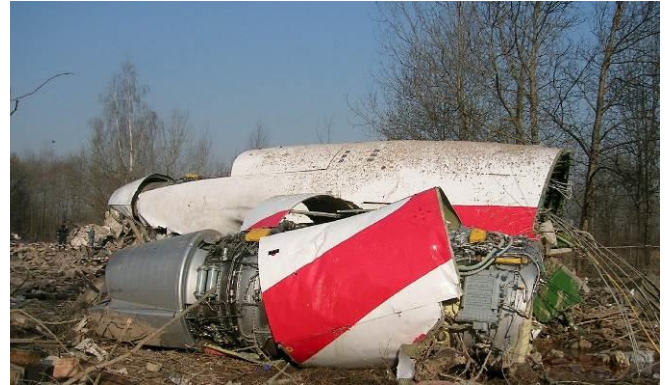
Fig. 22 and Fig. 23 show bundles of electric wires pulled out of the fuselage as a result of axial forces acting inside the fuselage. The origin of these forces can only be explained by internal explosion in the fuselage.

**Fig. 22.** Distinctive bundles of electric wires pulled out from the rear portion of the fuselage torn around the frame No. 65 at the crash site [5 8].

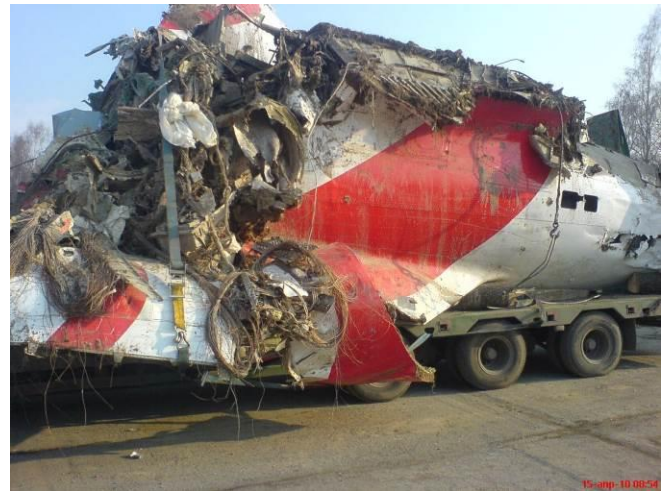
**Fig. 23.** Transportation of the rear portion of the fuselage shown in Fig. 22 from the crash site to the storage place. Pulled out electric wires are clearly visible.

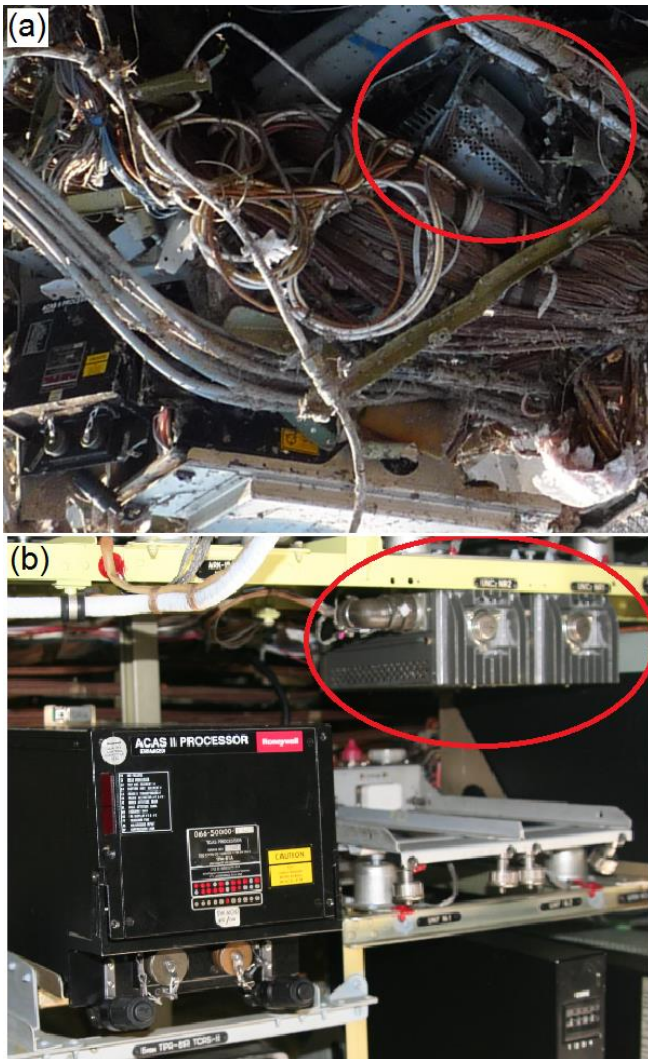
Fig. 24a shows low-frequency amplifiers YH4 in the technical compartment No 1 (avionics compartment) after the crash, while Fig. 24b shows undamaged amplifiers of the Tu-154M PLF2. The compartment No 1 is located under the cockpit. The photograph in Fig. 24a, which shows a heap of debris is turned upside down with respect to the original photograph [7]. In the bottom left corner of Fig. 24 there is the airborne collision avoidance system ACAS, also called the traffic-alert and collision avoidance system (TCAS)<sup>1</sup> [7].

Fig. 24. Low frequency amplifiers YH4: (a) after the crash; (b) in the technical compartment No 2 of the Tu-154 PLF2. Source: [www.fakty-smolensk.gov.pl](http://www.fakty-smolensk.gov.pl) [7].
