HYPOTHETICAL COLLISION OF TU-154M WITH BIRCH TREE VERSUS FULL-SCALE CRASH DYNAMIC TESTS OF DC-7 AND LC-1649

Jacek F. Gieras

A comparative analysis of hypothetical collision of Tu-154M with birch tree, full-scale dynamic crash test of Douglas DC-7 and full-scale dynamic crash test of Lockheed Constellation 1649 has been presented. The analysis pertains to the technical data of the Tu-154M, DC-7 and LC-1649 airliners, differences in their construction and conditions of collision /impact.

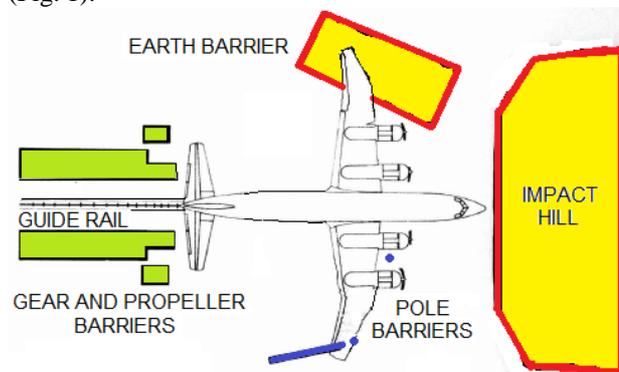
Fig. 1. DC-7 test site and wing impact sequence. Telephone poles have been marked with blue color [5].

- The gear barrier torn out the right main landing gear, which struck the right horizontal stabilizer (Fig. 12c).
- The impact with the outer pole (Fig. 1) cut off the right wing approximately 3.66 m (12 feet) from the tip. The main tank No 4 (Fig. 13) was ruptured by the pole.

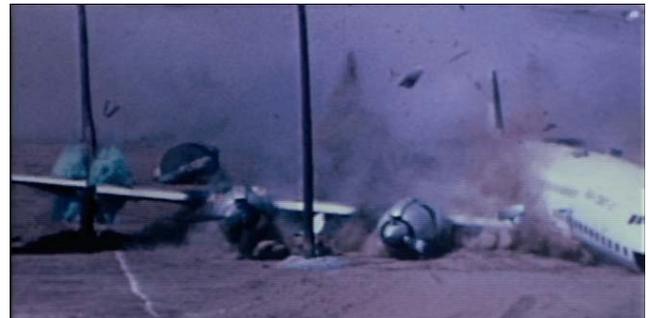
Fig. 2. LC-1649 full-scale dynamic crash test. Outboard pole impact [6].

- The left wing struck the earthen barrier and started to separate from the fuselage at the wing root, while the right wing hit the poles.
- The first pole nearly sheared off the outer panel of the right wing and opened up the fuel tank No 4 (Fig. 14) about 7.6 m (25 feet) from the tip (Fig. 2). The second pole cut into the wing and the No. 3 fuel tank between the engines No 3 and No 4 (Fig. 14). The portion of the right wing inboard of the No 3 engine nacelle remained attached to the fuselage throughout the crash (Fig. 3).

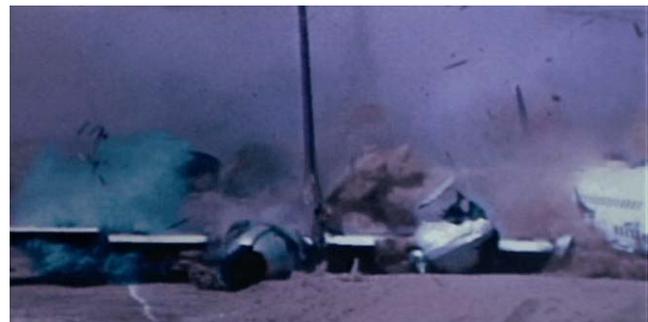
Fig. 3. LC-1649 full-scale dynamic crash test. Inboard pole impact [6].

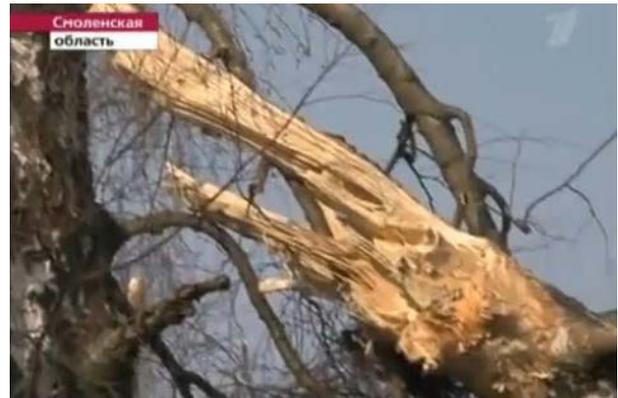
Fig. 10. Fracture of famous birch tree trunk. No piece of metal is visible. Photograph taken immediately after crash.

The famous birch tree has appeared two weeks after the crash. Before that, it was officially claimed that the wing of the plane hit the mast of the inner non-directional radio beacon (NDB) located 1100 m from the runway threshold. There is no clear evidence of detailed investigation of the famous birch tree and separated tip of the left wing. The photograph taken immediately after the crash (Fig. 10) does not show any pieces of metal embedded in the wood. The photographs taken by S. Amelin and J. Gruszynski also do not show chunks of metal.

- Research performed by K. Nowaczyk [8], photographs of the birch taken immediately after the crash (Fig. 10), appearance of trees broken by wind gusts, lack of damage to the slat (Fig. 11) and lack of detailed investigation of the birch tree and wing testify that there was rather no collision of the Tu-154M Nr 101 with the trunk of a birch tree.

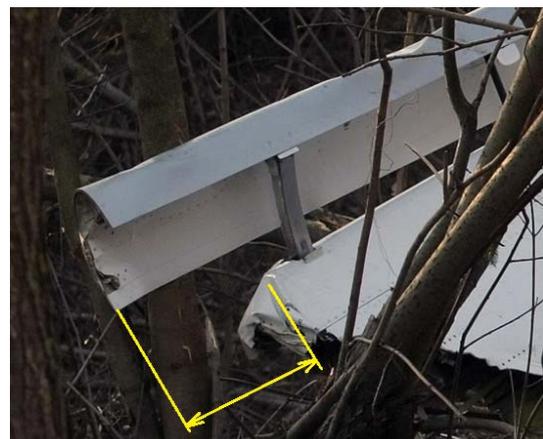
Fig. 11. Tip of the left wing. The wing has been cut off while the slat is intact. <http://vfl.ru/fotos/aa582e8c473661.html>

The tip of the severed wing looks peculiar (Fig. 11). The slat has not been damaged and protrudes several inches beyond the cut-off line of the wing. Slat of the left wing have been almost intact along the entire length, only with

three small cavities. The report [3] does not explain why the adjacent slat, extending in the direction of the fuselage had not been destroyed by the hypothetical collision with the trunk of a birch tree, and how did it happen that the zone of destruction begins behind the slat (Fig. 11).

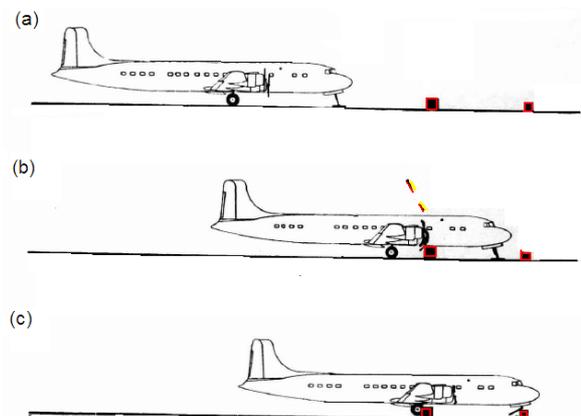
- The first barrier was the landing gear barrier (Fig. 12a).
- All four propellers were broken as a result of hitting the propeller barriers (Fig. 12b). All four engine mounts failed.

Fig. 12. Gear and propeller impact sequence: (a) aircraft approaching gear and propeller barriers; (b) impact with propeller barrier; (c) impact with main and front landing gear barrier [5].
