EVALUATION, INVESTIGATION TECHNIQUES AND POSSIBILITY OF MALFUNCTION OF ELECTRIC SYSTEM OF TU-154M

Jacek F. Gieras

Keywords – aircraft electric power system, failure, investigation after crash, synchronous generator, Tu-154M.

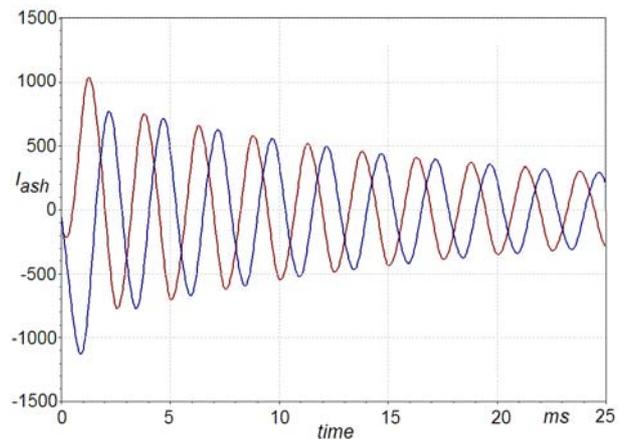
Fig. 8. Armature current I_{ash} at two lines-to-neutral short circuit of ГТ40ПЧ6 synchronous generator. The peak short-circuit current is $I_{ashp} = -1130$ A corresponds to $t = 0.6$ ms.

Short-circuit currents of the ГТ40ПЧ6 synchronous generator can exceed more than 11 times the nominal (rated) current $I_a = 111$ A. The most dangerous are line-to-neutral and two lines-to-neutral short circuits. Fig 8 shows the armature current $I_{ash} = f(t)$ waveforms for two lines-to-neutral short circuits, as obtained from the 2D FEM.

The abnormal paralleling of two unsynchronized ГТ40ПЧ6-2С generators causes serious consequences. The generators were connected on the network after the engine start and exit to the idle mode. Under such conditions the currents can reach more than 10 times the nominal current of the generator (Fig 8).

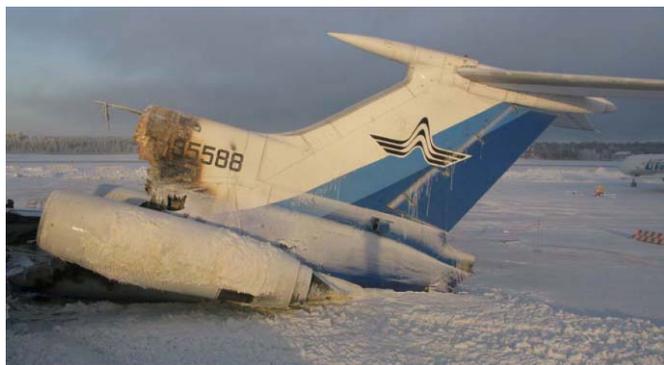
Russia's Interstate Aviation Committee (IAC) released their final report (in Russian) concluding the probable cause of the accident was the outbreak of fire in the right generator panel located between frames 62 and 64 in the cabin [2].

Fig. 9. Tail part of Tu-154B-2 RA-85588 after fire at Surgut airport on January 1, 2011 [2].

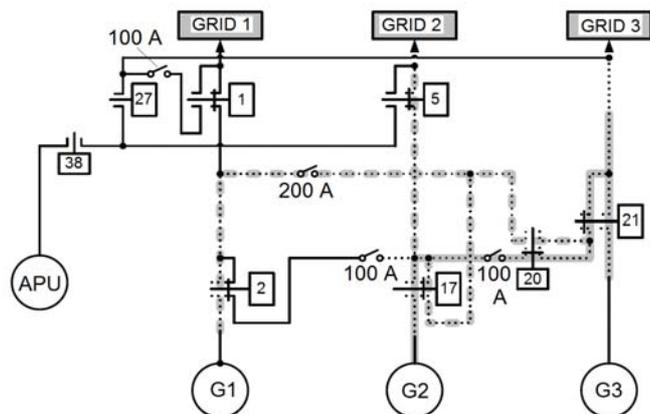
Fig. 10. Closed electric circuit on assumption of abnormal scenario corresponding to 21st contactor TKC233Д0Д “switching generator No 3 on grid” [2].

The cause of the fire was an electrical arcing produced by electrical currents exceeding 10 to 12 times the nominal current when two generators not synchronized with each other were brought online but got connected together instead of being connected to parallel busses. The unsynchronized operation of the generators can be attributed to:

- (a) Poor technical conditions of contacts TKC233Д0Д responsible for connecting the generators with the electrical busses, that were damaged by prolonged operation without maintenance. A contact normally open was welded and fractured insulation material moved between contacts that are normally closed. These abnormal contact positions led to the connection between No 2 and No 3 generators (Fig. 10).
- (b) Differences in the schematic diagrams of generator No 2 and generators No 1 and 3. When the switch is moved from "check" to "enable" with no delay in the "neutral" position, the generator 2 is brought online without time delay. This leads to increased wear of normally closed contacts in the TKC233Д0Д unit. The specific design of the electrical systems ensures power supply to each bus from either the APU or engine integrated drive generator.

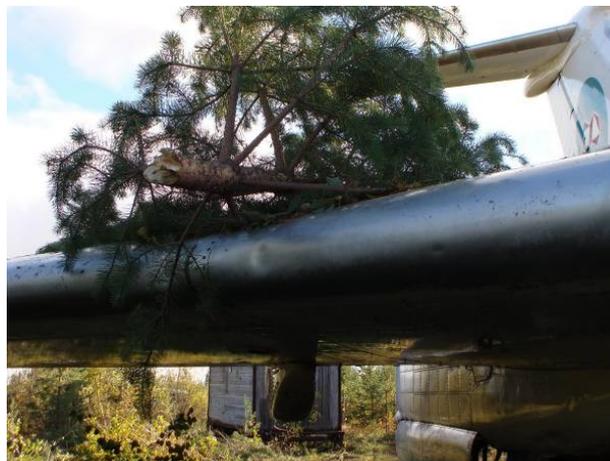
Fig. 11. Emergency landing of Tu-154M RA-85684 at abandoned air strip near town of Izhma on September 7, 2010. The impact was damped by the young trees which have grown since the airport was closed. The photograph shows the right wing that cut a pine tree. <http://englishrussia.com/2011/11/04/the-lucky-tu-154/#more-74596>

After emergency decent below cloud level the crew were able to spot an abandoned air strip near town of Izhma (Fig. 11). The abandoned air strip is 1325 m long, whereas Tu-154 requires a minimum of 2200 m. The aircraft landed at a speed of 350 to 380 km/h, faster than normal, due to the lack of flaps. Although the flaps are powered by hydraulics, the switches operating them are electrical. All nine crew and 72 passengers evacuated using the aircraft's evacuation slides. No injuries were reported.

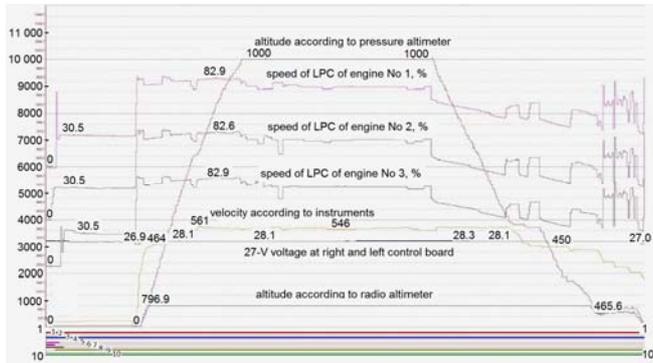
Fig. 12. Parameters of flight of Tu-154M Nr 101 for electrical equipment and installation on April 10, 2010, 7:14– 8:41 am. LPC = low pressure compressor. Description in Table 4 [4].

According to latest research of K. Nowaczyk of the University of Maryland¹, the ATM quick access recorder (QAR) has recorded a damage to the left engine No 1 and synchronous generator No 1. Both the 115/200 V and 36 V

(LSIEC36) of the left grid dropped to zero before the ground impact (Table 4).

Credibility of flight parameters for electrical equipment and installation (Fig. 12) is questionable. There is not enough information how the recorded parameters have been extracted and analyzed [4]. It is now very difficult to find out if the electric power system was operating correctly in the last seconds of crash or not. According to [3,4], the flight management system (FMS) lost electric power (memory freezing) at 10:41:05, i.e., at the time of collision with ground. Table 3 show standard procedure for examination of electrical equipment and installation after crash [1,11]. The electrical equipment and wiring at the crash site was only inspected visually [3,4]. There is still possible to examine synchronous generators and induction motors for fuel pumps and for other on-board equipment, e.g., air conditioning system. However, the results of examination may not be credible since the wreckage was carelessly loaded on the trailers, and then transported, unloaded and stored in open space without any caution.

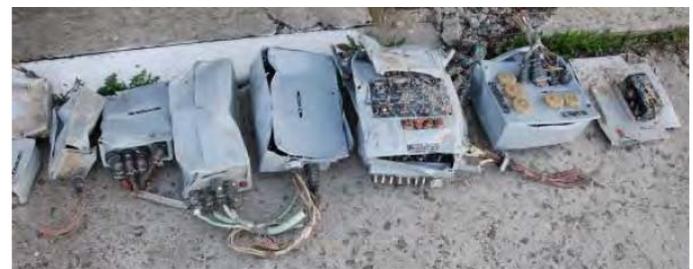
Fig. 13. Junction and control boxes of electrical installation. Photo taken at the site of wreckage storage [4].

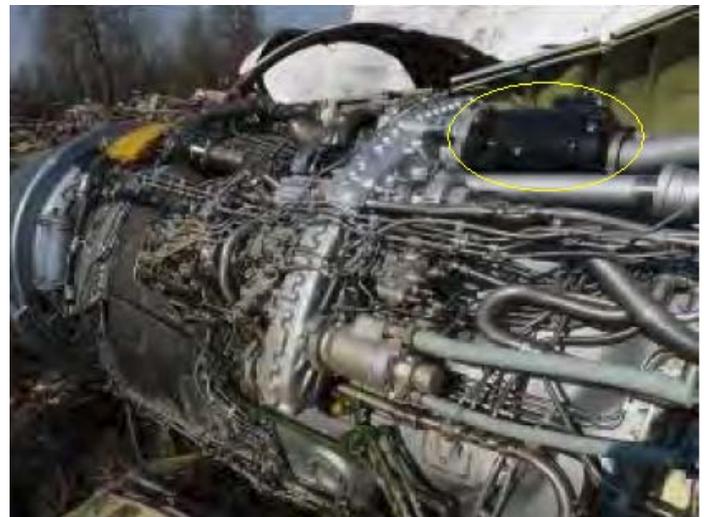
Fig. 14. Generator ГТ40ПЧ6 on Nr 1 (left) Д-30КУ turboprop engine. Photo taken between 11 and 13 April 2010 on the crash site [4].

There is no evidence that other than visual inspection of electrical equipment and wiring (Table 3) has been done on the crash site [3,4]. The following statement is given on p. 20/28 of Annexure 4 [10]: *Bundles of electrical wires torn apart. Control boxes deformed. Enclosures of on-board batteries deformed. Some cells leaking.* The report shows photographs of wire bundles, control boxes (Fig. 13), synchronous generator ГТ40ПЧ6 on the turboprop engine Nr 1 (Fig. 14), batteries and other electrical equipment.

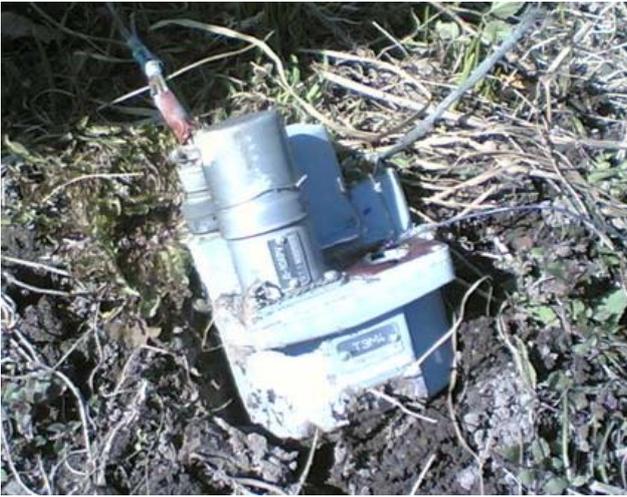
Fig. 15. Electromagnetic brake TЭM-4 for flap control found several meters behind the famous birch tree. Source: <http://www.waronline.org>

The object found at the crash site several meters behind the famous "armored" birch tree [3] and shown in Fig. 15 has been often incorrectly identified as a fuel pump. However, this is the electromagnetic brake TЭM4 used for control of flaps (Fig. 16).
