# HYPOTHESIS OF EXPLOSION IN THE LEFT WING OUTER FUEL TANK OF TU-154M DUE TO ELECTRICAL IGNITION OF FUEL-AIR MIXTURE

Jacek F. Gieras

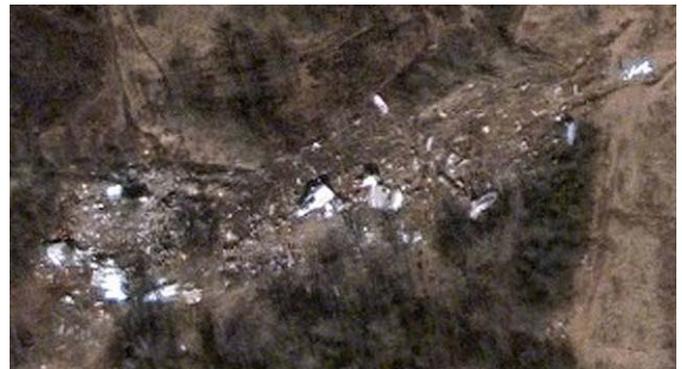
Fig. 1. Plane crash site on April 12, 2012. Source: Global Digital.

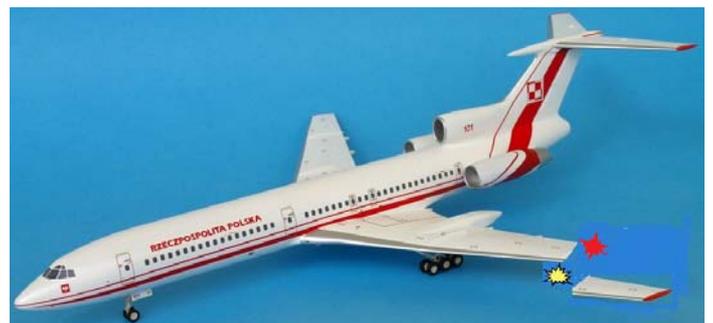
Fig. 2. Hypothesis of explosion in the left wing: lost of the 6.1-m long portion of the left wing.

According to [8], Section 4.10.3, *the lost of the left portion of the wing has caused the burst of the left fuel tank Nr 3, which is placed between rib nr 14 and 45. The severance of the 6.1-m long tip of the left wing was between the ribs nr 27 and 28.*

the problem can be stated in opposite way: *The burst of the left fuel tank Nr 3 caused lost of the left portion of the wing.*

According to G. Szuladzinski [16], the Tu-154M No 1 crash was due to two explosions in the air: one on the left wing (Fig. 2) and the second inside the fuselage.

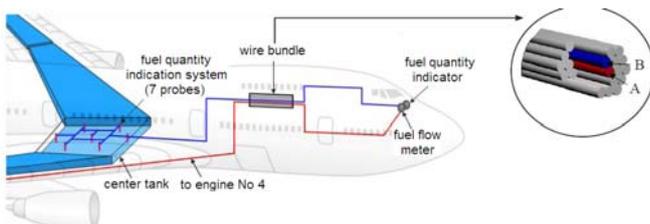
Fig. 4. Wiring configuration on the Boeing 747. Investigators suspect that high voltage from the fuel flow meter A passed to the fuel quantity indication system (FQIS) B because of a short circuit in the wire bundle [15].

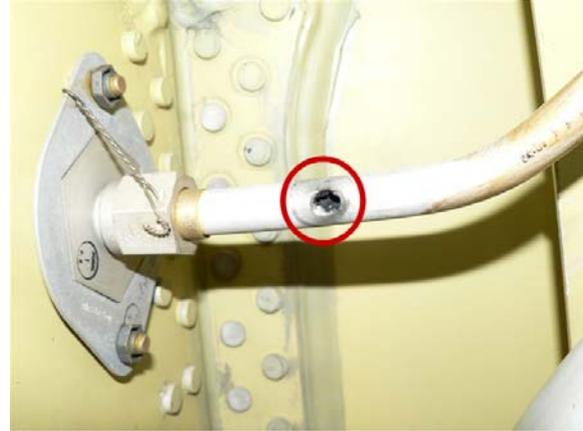
Explosion in the left wing fuel tank also took place on May 4, 2006 in Boeing 727-200 belonging to Malaysian Transmile Airline at Bangalore Airport, India [18]. Boeing 727 is very similar to Tu-154M. Explosion destroyed the structural integrity of the left wing. Investigators have found damaged electrical installation and electrical arcing in aluminum tube with 115-V AC cable feeding fuel pump motor in the left wing tank (Fig. 5).

Fig. 5. Evidence of electrical arcing of the wiring inside the exploded fuel tank of Boeing 727-200, Transmile Airlines, Bangalore, May 4, 2006 [18].

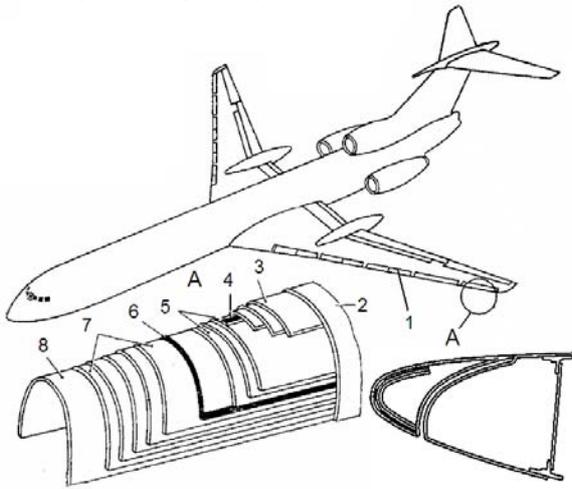
Malfunction of anti-ice electric heating system installed in slats (Fig. 9) could lead to local temperature rise in the tank wall and create friendly conditions for fuel ignition by sparks or arcing. Fuel vapor *auto-ignition* due to local hot spot in fuel tank, or temperature rise due to malfunction of anti-ice electric system or other electrical equipment/wiring is rather impossible, since the auto-ignition temperature of Jet A-1 fuel is 210°C (Table 3). More realistic is *electrostatic charge build-up* due to fuel flow and hazardous electric potential level inside the tank.
