Report No. 456

## SOME TECHNICAL AND STRUCTURAL ASPECTS OF THE SMOLENSK PLANE CRASH

Author: Dr Gregory Szuladzinski

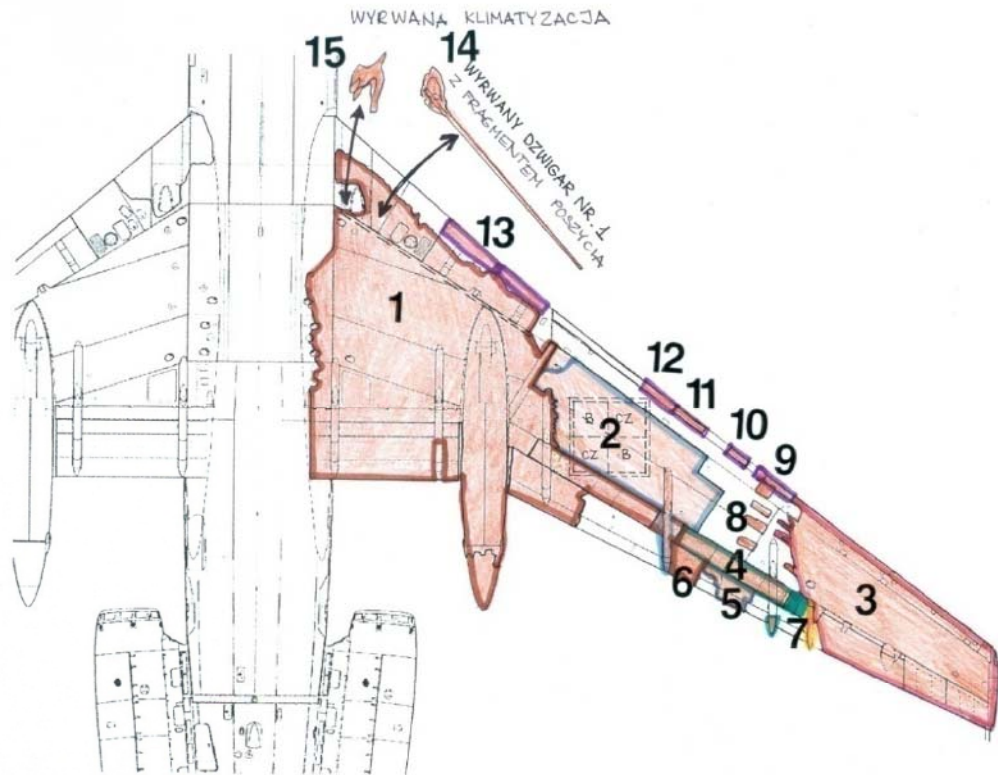
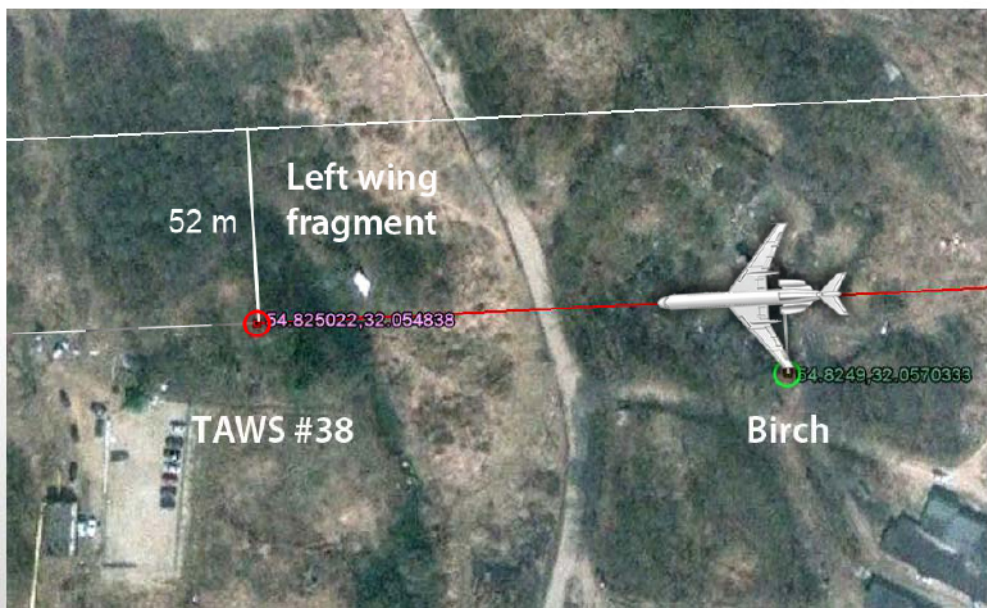
The left wing, view from the bottom. The parts are pieced together based on images from the day of the incident.

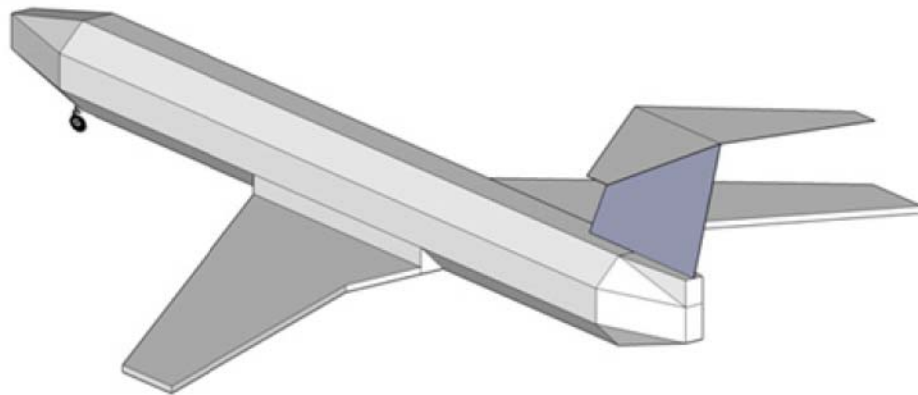
## Phase I

Internal or external explosion in front of the left wing

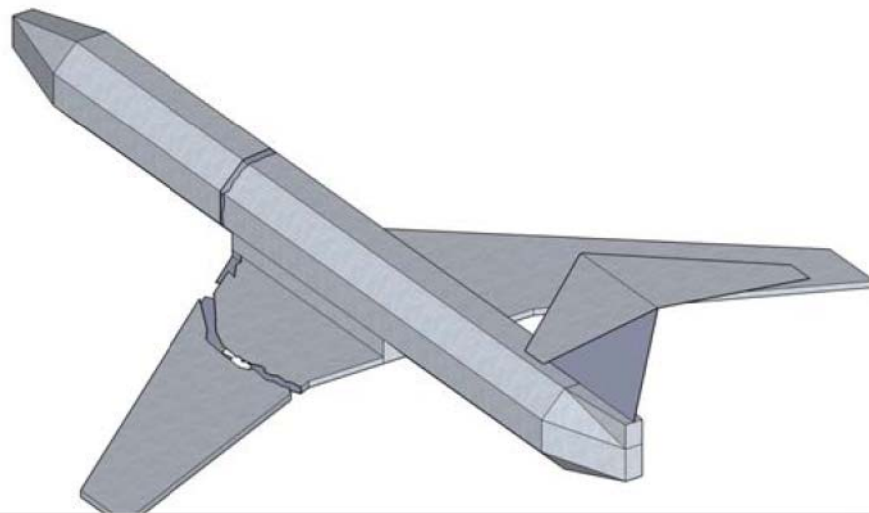
## Phase II

Internal explosion in central position in airframe

The loss of the wing's leading edge near the fuselage and the entire left-most part of the wing had two aerodynamic effects: loss of lift on the left side and increase of drag. The first effect induces roll to the left, while the second one induces a change in magnetic heading.

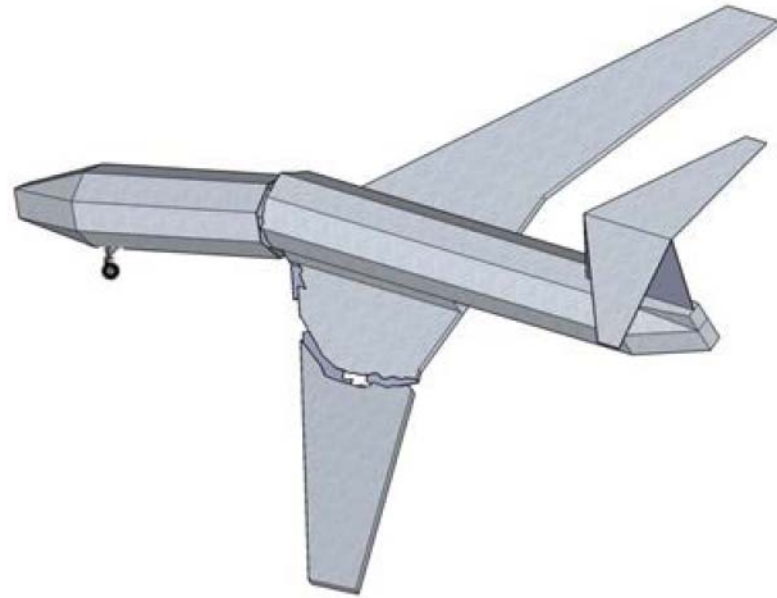
### Phase III

The rear part of the airframe with wings and vertical stabilizer rolls to the left independently of the front part which stays in its natural position

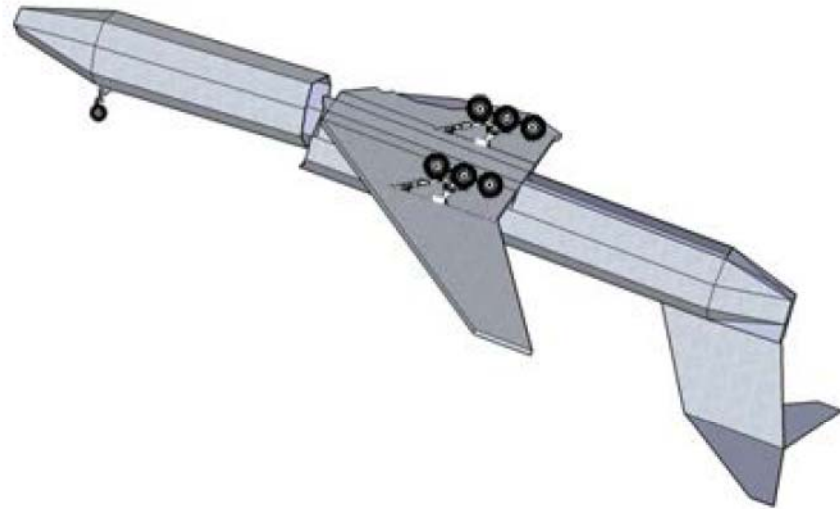
### Phase IV

Impact with the ground: only the rear part of the fuselage is inverted.

Angular momentum about the roll axis breaks the fuselage apart completely, separating the front of the fuselage from the rear, with the rear continuing to roll to the left.

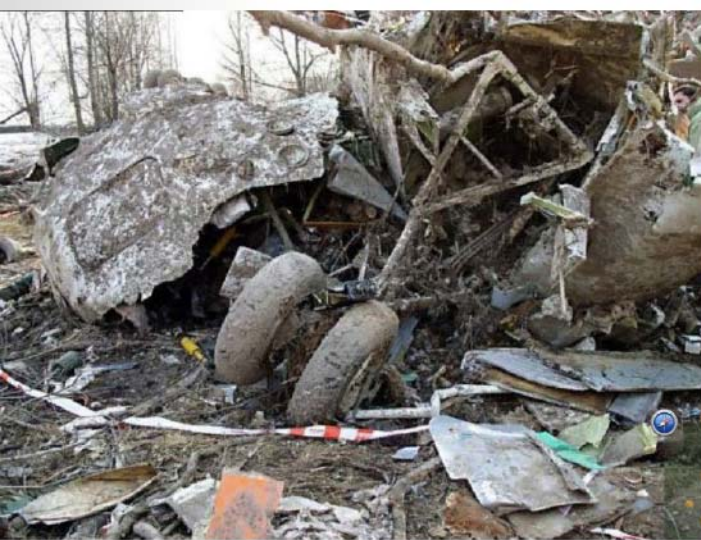
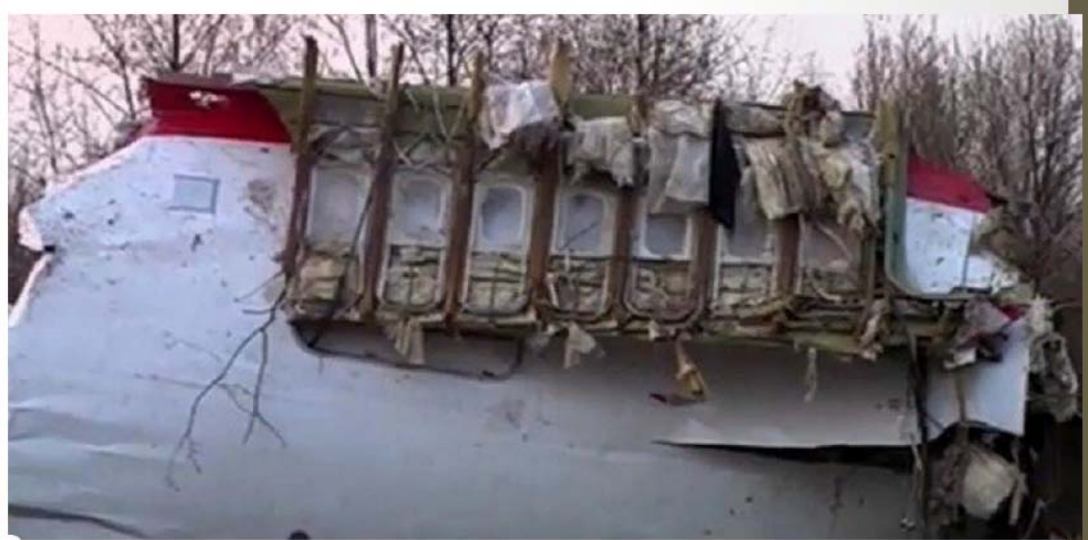
Cockpit and front part of fuselage are not inverted

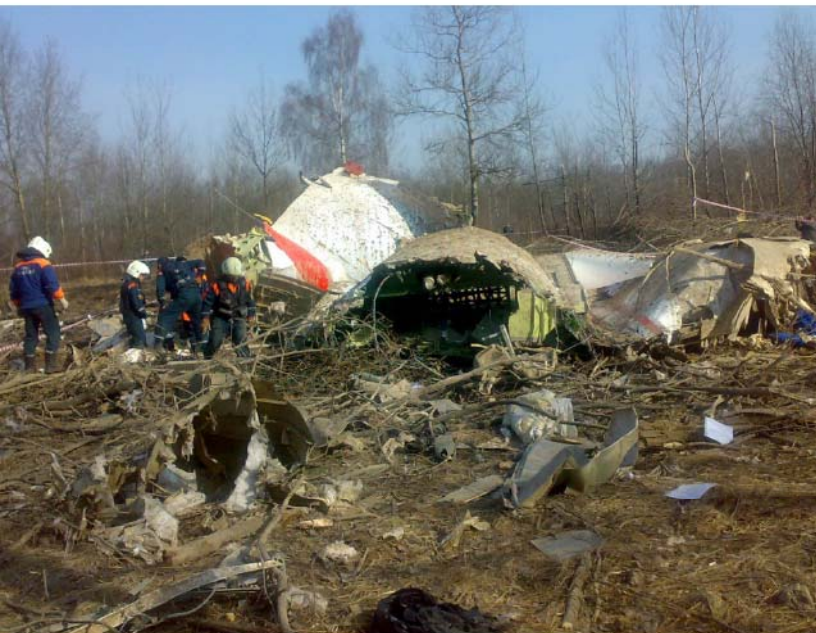
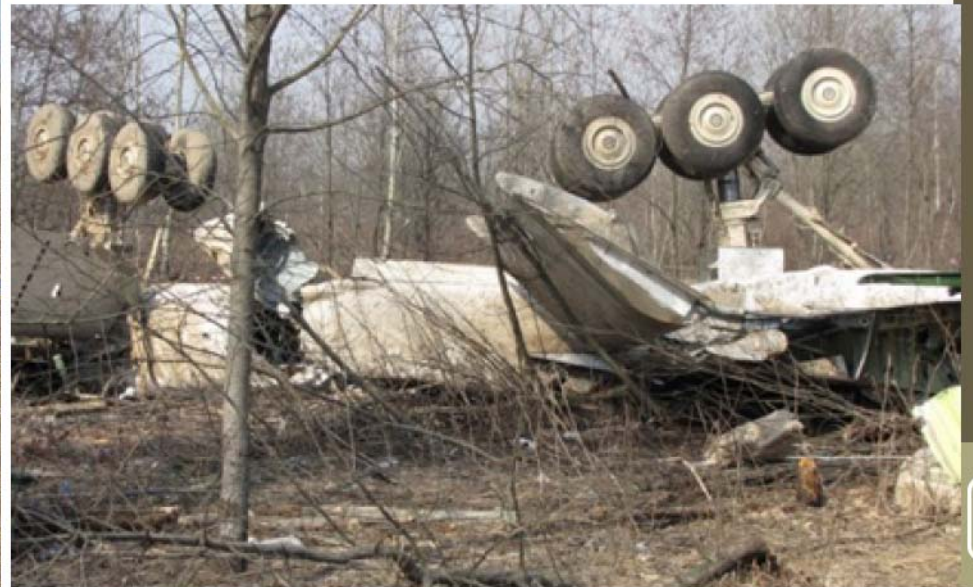
Rear parts of the fuselage in inverted position
