HYPOTHETICAL COLLISION OF TU-154M WITH BIRCH TREE VERSUS FULL-SCALE CRASH DYNAMIC TESTS OF DC-7 AND LC-1649

Professor **Jacek F. Gieras**, PhD, DSc, Fellow IEEE
University of Technology and Life Sciences, Bydgoszcz, Poland

Smolensk Conference, Warsaw, 22.10.2012

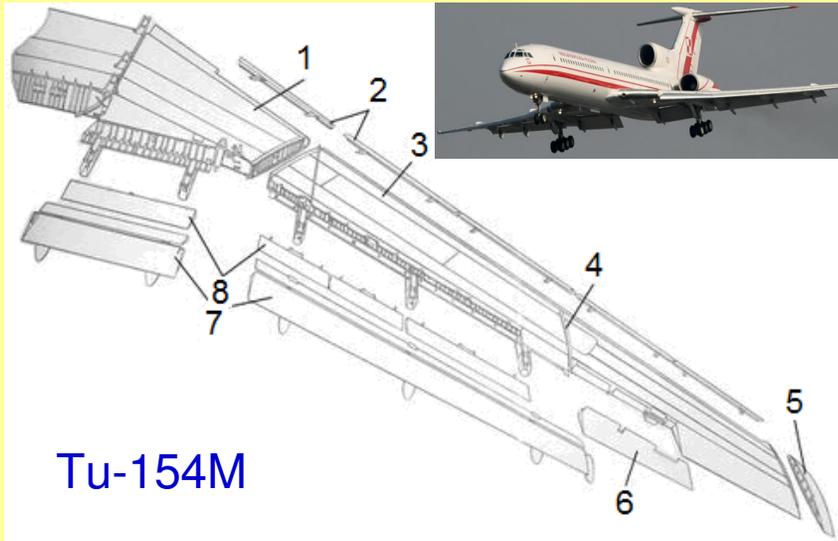
Tu-154M

The first version of the **Tu-154M** was designed in 1964, while the **DC-7** was designed before 1953 and **LC-1649** before 1943. The **turbofan** engines of the **Tu-154M** are mounted in the rear of the fuselage. The **piston engines** of the **DC-7** and **LC-1649** are buried in wings

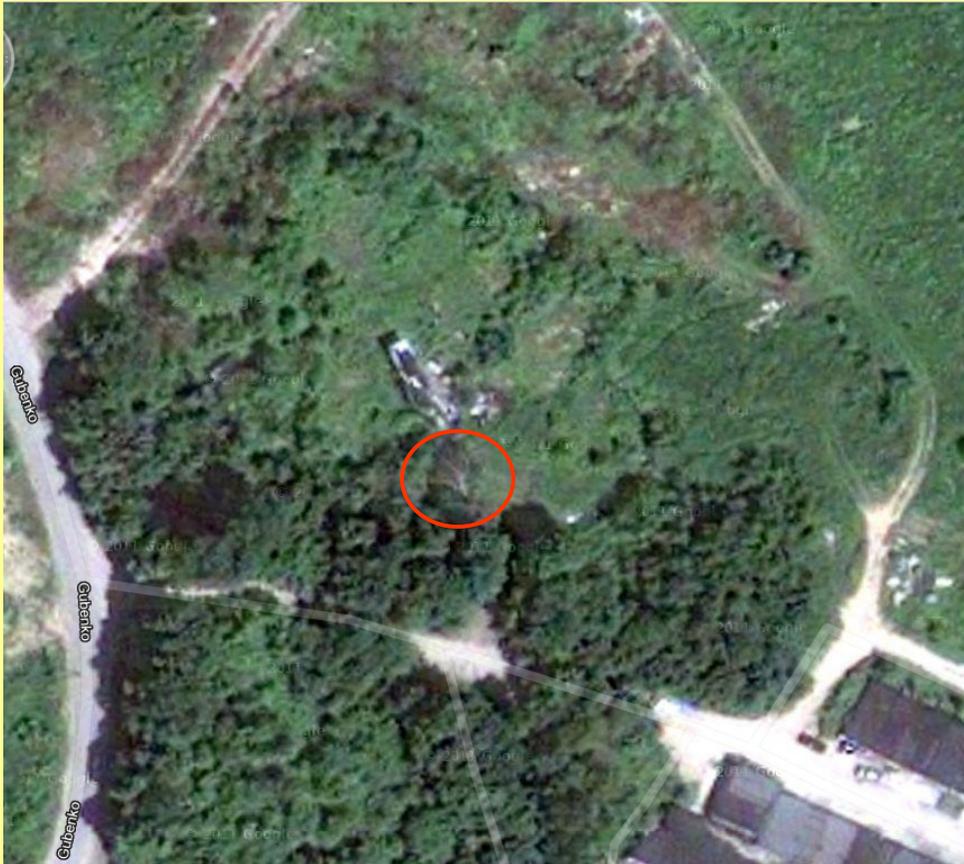
Recent photographs. Dr Bodin's lot with “armored” birch tree
