HYPOTHETICAL COLLISION OF TU-154M WITH BIRCH TREE VERSUS FULL-SCALE CRASH DYNAMIC TESTS OF DC-7 AND LC-1649

Jacek F. Gieras

A comparative analysis of hypothetical collision of Tu-154M with birch tree, full-scale dynamic crash test of Douglas DC-7 and full-scale dynamic crash test of Lockheed Constellation 1649 has been presented. The analysis pertains to the technical data of the Tu-154M, DC-7 and LC-1649 airliners, differences in their construction and conditions of collision /impact.

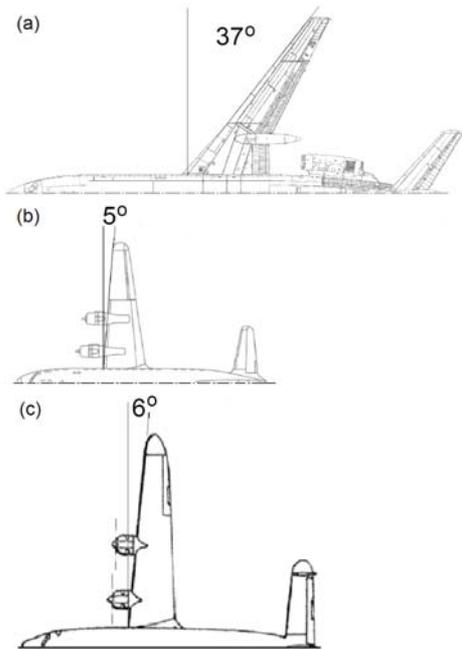
Fig. 9. Leading edge sweep of wings of (a) Tu-154M, (b) DC-7 and (c) LC-1649 aircraft.

The *leading edge sweep*¹ of the wing (Fig. 9) is about 37° for the Tu-154M, about 5° for the DC-7 and about 6° for the LC-1649 aircraft (Table 1). It is easier to cut a pole/tree barrier by a wing with large leading edge sweep angle (Tu-154M) than by a wing almost perpendicular to the center line of the fuselage (DC-7, LC-1649). For example, to decrease the amount of force required in a guillotine cutter and to cut the material more swiftly, the blade is angled. This angle is referred to as the *shear angle*. A 5° degree shear angle decreases the force by about 20%, but increases the stroke.

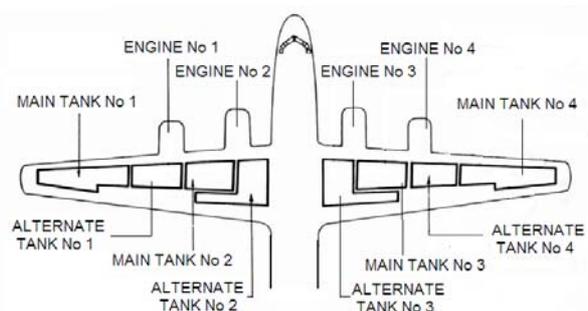
Fig. 13. DC-7 fuel tank and engine locations [5].

- The gear barrier torn out the right main landing gear, which struck the right horizontal stabilizer (Fig. 12c).
- The impact with the outer pole (Fig. 1) cut off the right wing approximately 3.66 m (12 feet) from the tip. The main tank No 4 (Fig. 13) was ruptured by the pole.

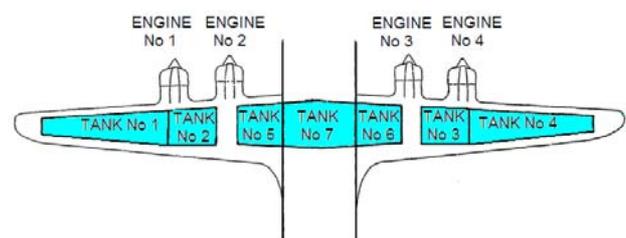
Fig. 14. LC-1649 fuel tank and engine locations [6].

- The aircraft hit the second inner pole approximately 0.15 s after the first pole impact. The inner pole struck the right wing between engines No 3 and No 4 (Fig. 14). The wing leading edge structure back to the forward spar was crushed. Then, the inner pole broke.

- The left landing gear was broken and caused the engine No 2 (Fig. 14) to roll under the left wing.
- The right landing gear was also broken and severed the right vertical fin of the right horizontal stabilizer.
- The propeller of the engine No. 2 (Fig. 14) was sheared off by the landing gear barrier.
- The engines No 1, 3, and 4 (Fig. 14) and their propellers were intact, with the exception of one propeller blade of the engine No 3, which was sheared off by the right main gear barrier.
- The rail guide shoe was broken off on impact with the nose gear barrier. The gear strut was forced into the forward fuselage.
- After passing through the gear barriers and hitting the earth, propellers on engines No 1, 3, and 4 (Fig. 14) lost their blades. A tear in the wing structure adjacent to the engine nacelles became visible.

- The left wing struck the earthen barrier and started to separate from the fuselage at the wing root, while the right wing hit the poles.
- The first pole nearly sheared off the outer panel of the right wing and opened up the fuel tank No 4 (Fig. 14) about 7.6 m (25 feet) from the tip (Fig. 2). The second pole cut into the wing and the No. 3 fuel tank between the engines No 3 and No 4 (Fig. 14). The portion of the right wing inboard of the No 3 engine nacelle remained attached to the fuselage throughout the crash (Fig. 3).
