EVALUATION, INVESTIGATION TECHNIQUES AND POSSIBILITY OF MALFUNCTION OF ELECTRIC SYSTEM OF TU-154M

Jacek F. Gieras

Keywords – aircraft electric power system, failure, investigation after crash, synchronous generator, Tu-154M.

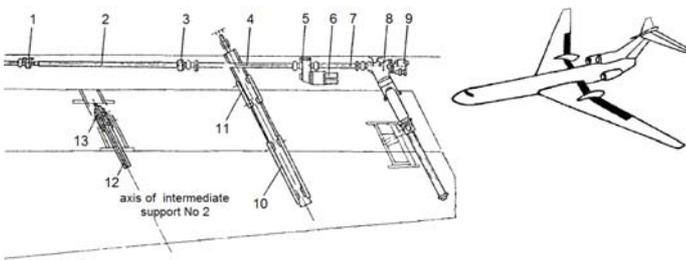
Fig. 16. Location of electromagnetic brake TЭM-4 for flap control. 1,3 - bracket, 2,4 - transmission shaft, 5 - reducer, 6 - electromagnetic brake TЭM-4, 7 - cardan joint, 8 - lift for the outer flap, 9 - mechanism of limit switches with sensor, 10 - rail of external deflector, 11 - carriage of external deflector, 12 - rail of deflector, 13 - intermediate carriage of deflector [9,10].

The object found at the crash site several meters behind the famous "armored" birch tree [3] and shown in Fig. 15 has been often incorrectly identified as a fuel pump. However, this is the electromagnetic brake TЭM4 used for control of flaps (Fig. 16).
