# HYPOTHESIS OF EXPLOSION IN THE LEFT WING OUTER FUEL TANK OF TU-154M DUE TO ELECTRICAL IGNITION OF FUEL-AIR MIXTURE

Jacek F. Gieras

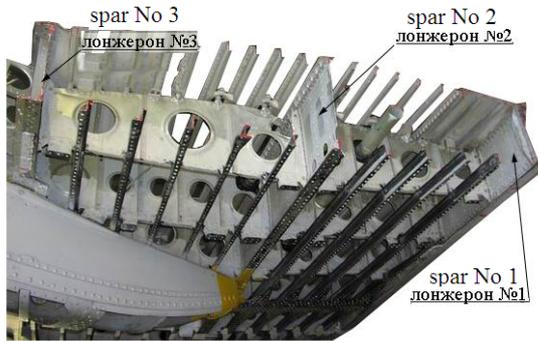
Fig. 3. Construction of Tu-154 wing [19].

The construction of Tu-154 wing is shown in Fig. 3. Its main parts are 3 spars, the upper and lower panels and 45 ribs. Wing ribs are perpendicular to the axis of the third spar. The chambers in their center parts are sealed and used as fuel tanks [1,17,19].

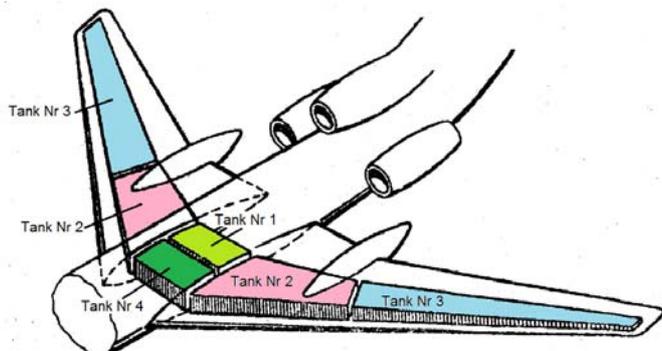
**Fig. 6. Tu-154M fuel tank configuration:** Nr 1 – center wing tank (CWT), i.e., collector tank, Nr 2 – inner left and right wing tank, Nr 3 – outer left and right wing tank, Nr 4 – additional tank [17].

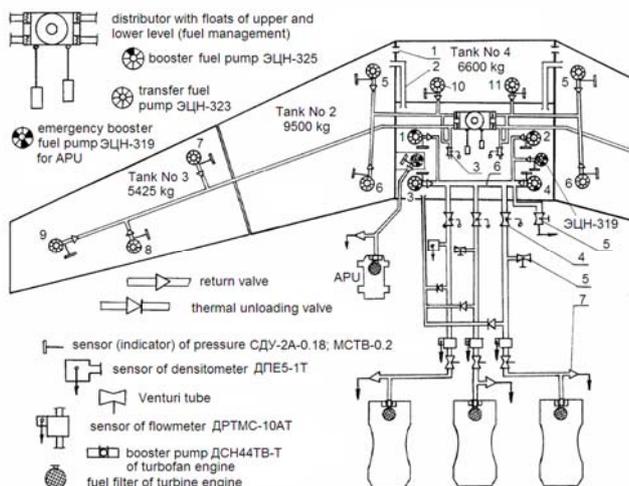
**Fig. 7. Tu-154M fuel system layout.** Fuel tanks, fuel pumps, fuel transfer lines, Д30КУ engine and APU have been shown. 1,2 – feed lines of upper transfer from tanks No 4 and 1 to tank 2; 3 – faucet of reserve transfer; 4 –antifire faucet; 5 – discharge faucet, 6 – connector for maintenance of engines [1,17,19].

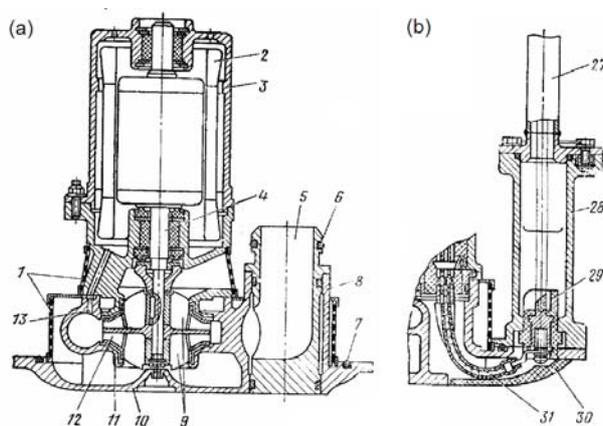
Fuel pumps of the Tu-154M are driven by 115/220-V induction motors and 27 V DC brush motors (Table 1). A flange mounted motor and pump constitute one integral unit (Fig. 8a). The feeding cables in fuel tanks are in aluminum tubes (Fig. 8b). Arcing in wiring system that delivers electric energy to fuel pump motors can theoretically ignite the *fuel-air mixture* in the wing tank [2,9,11,12,13].

**Fig. 8. Booster fuel pump ЭЦН-325:** (a) cross section of fuel pump and induction motor; (b) electric wires. 1 – cover (grid), 2 – induction motor, 3 – motor housing, 4 – shaft, 5 – tube, 6,7 – sealing rubber rings, 8 – pump housing, 9 – rotor, 10 – cover, 11 – snail, 12 – impeller, 13 – channel, 27 – conduit metal tube, 28 – tubing, 29 – terminal block, 30 – cover, 31 – electric cable. Construction of transfer fuel pump ЭЦН-323 is similar [1,17].

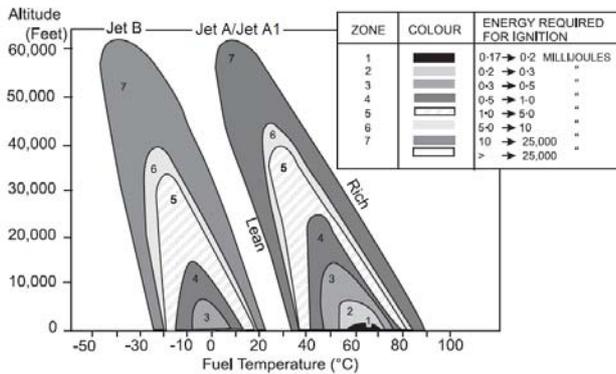
**Fig. 10. Flammability envelopes and estimated minimum electrical ignition energies for Jet A/Jet A-1 and Jet B fuels [2].**

The environmental parameters of temperature and altitude which will affect the flammability of the tank ullage, are illustrated by the so called *flammability envelope*. Traditional flammability envelopes have been available for many years [2]. The envelopes shown in Fig. 10 together with ignition energies, were derived by British Aerospace in the 1970's [2]. It should be noted that the flammability limits are not specification requirements, which include instead flash point, vapor pressure, and distillation of the particular fuel type.

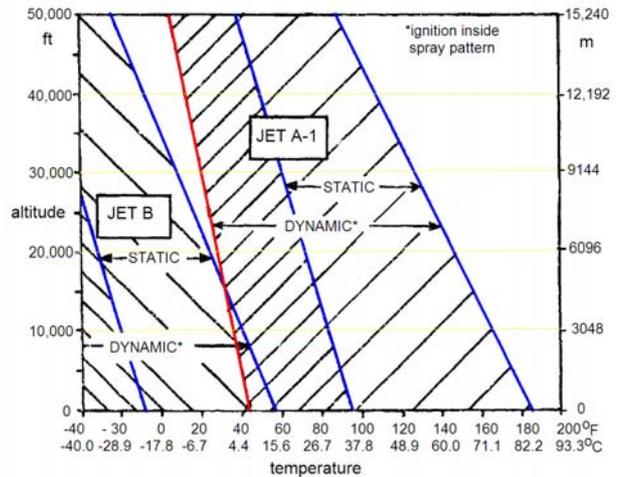
Under dynamic conditions (pressure and temperature transient), the flammability envelope extends towards lower temperatures, as shown in Fig. 11 [12]. The dynamic flammability envelope for Jet A-1 fuel shows, that the flash point at low altitudes is as low as 4 to 5°C.

**Fig. 11. Static and dynamic flammability envelopes for Jet A-1 and Jet B fuels [12].**
